TOWN OF WEST SENECA

Re: 32 Benson Ave
West Seneca, New York

Date: November 9, 2017

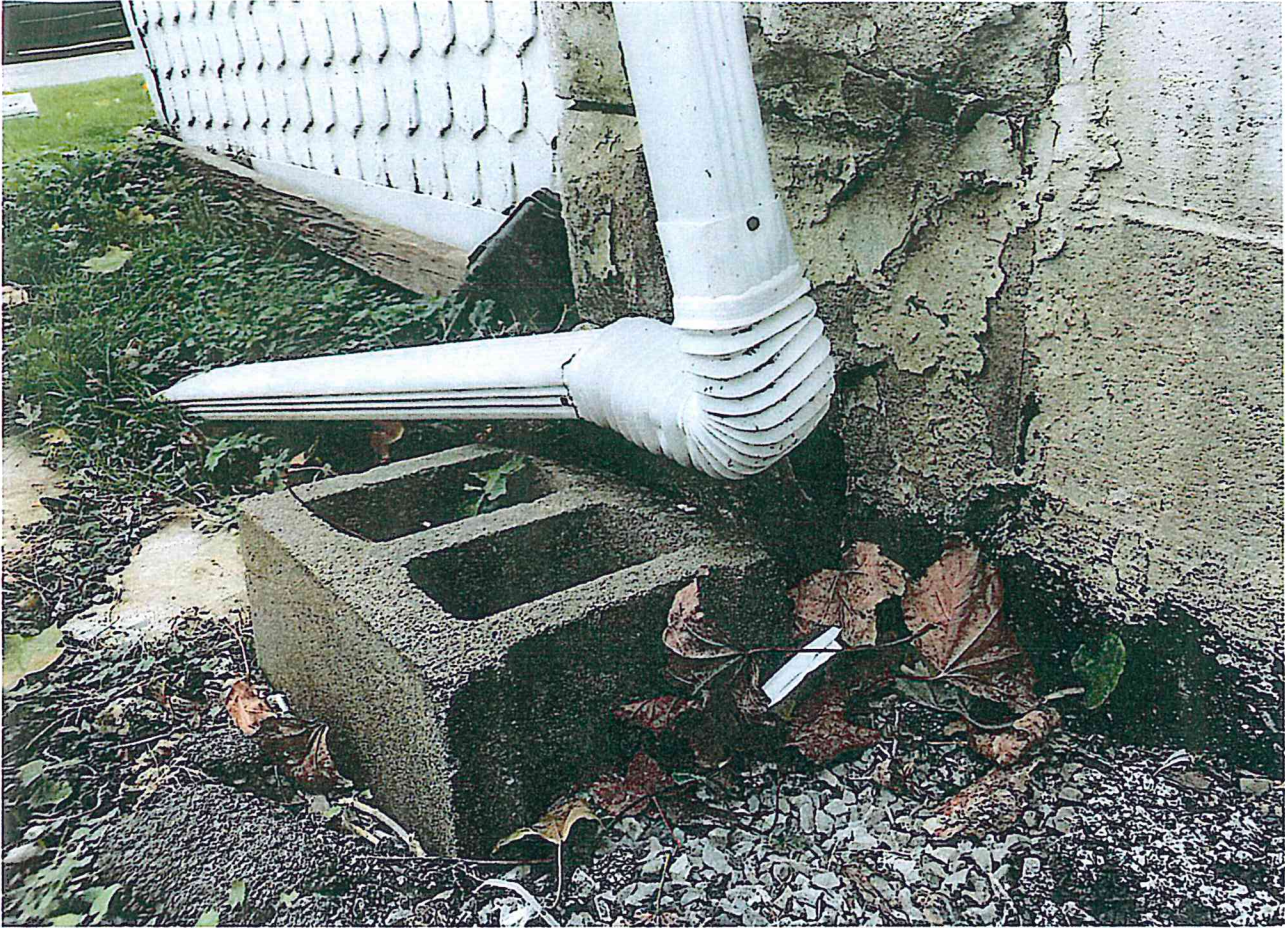
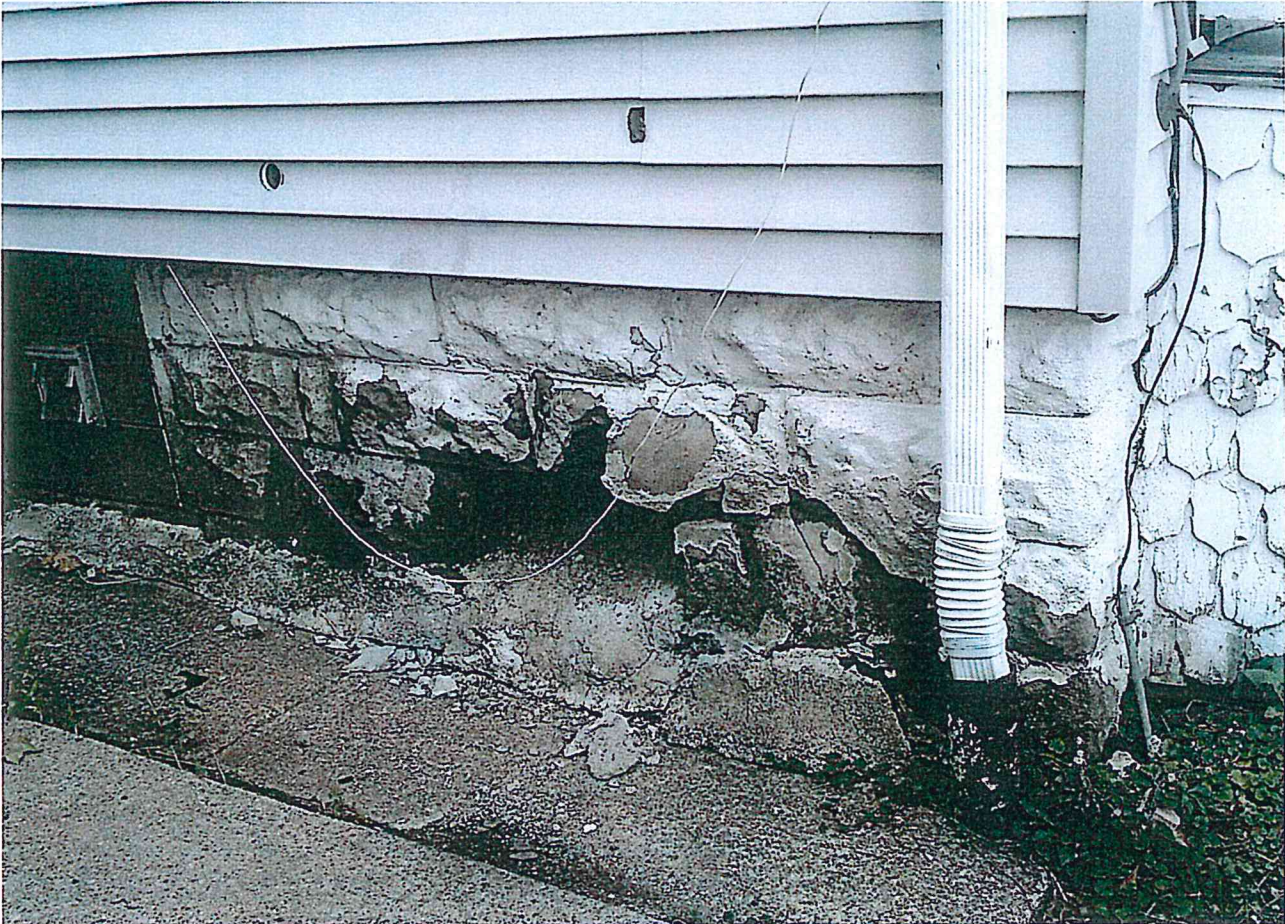
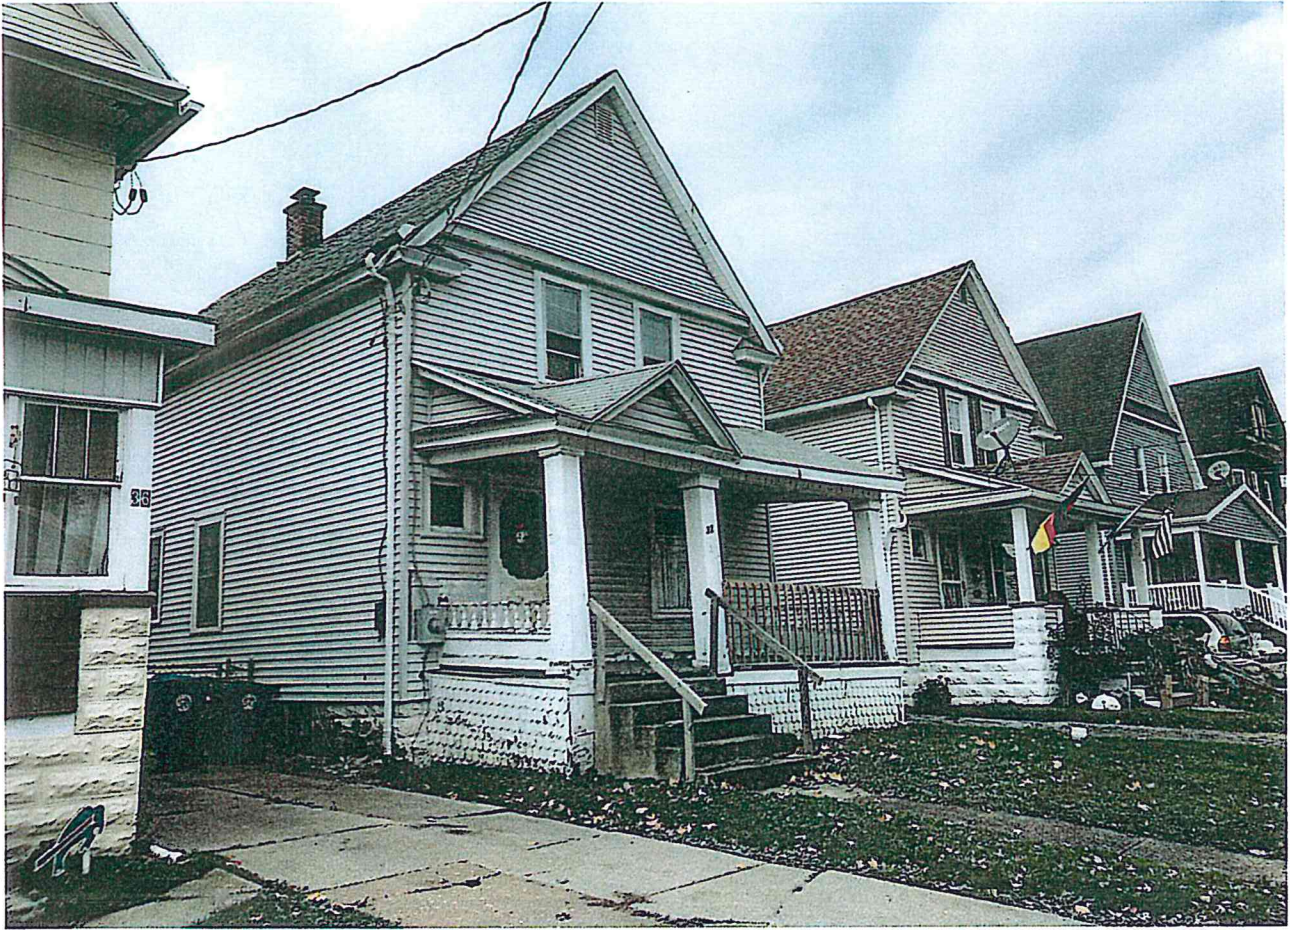
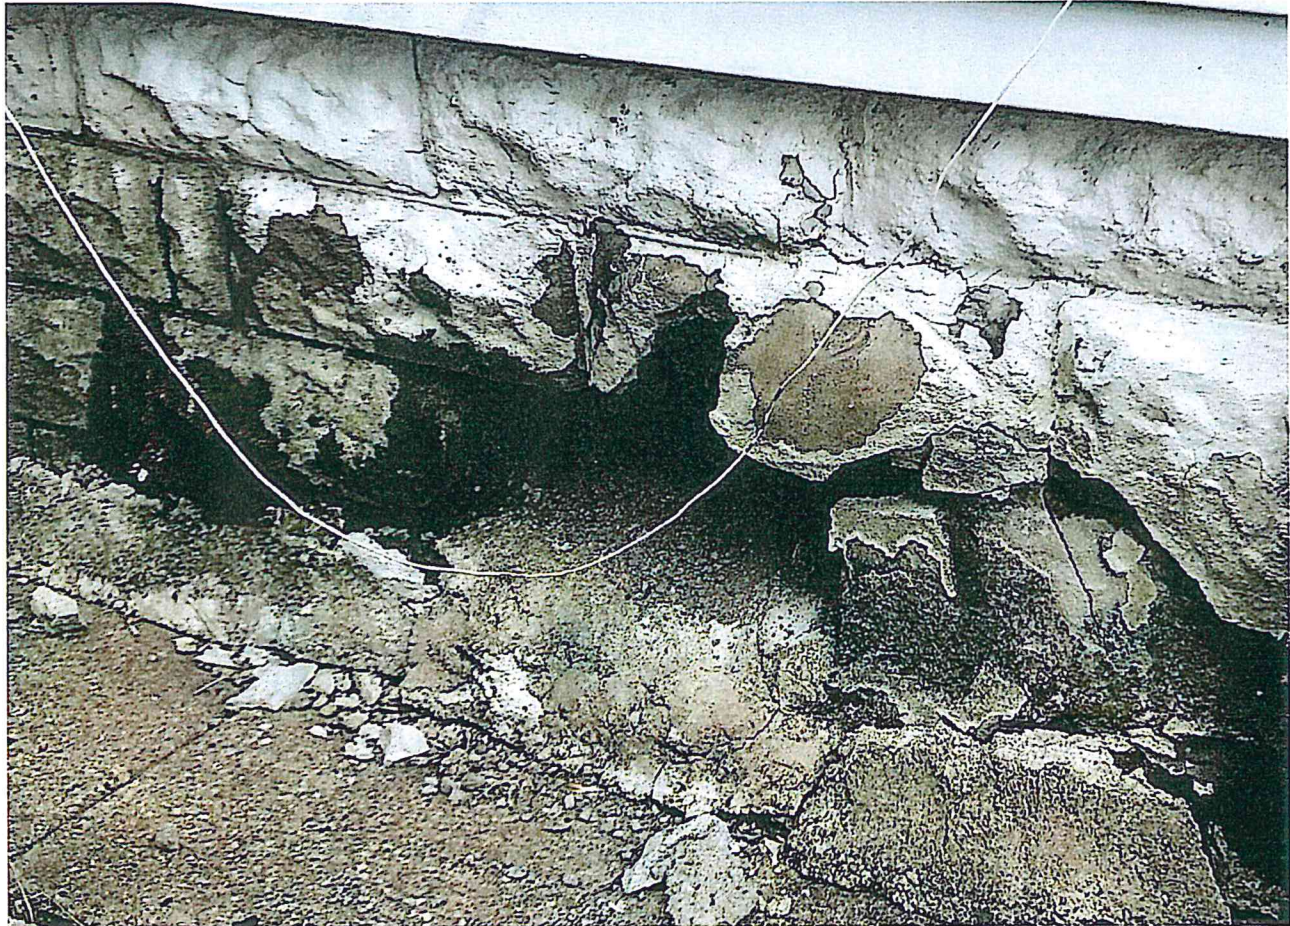
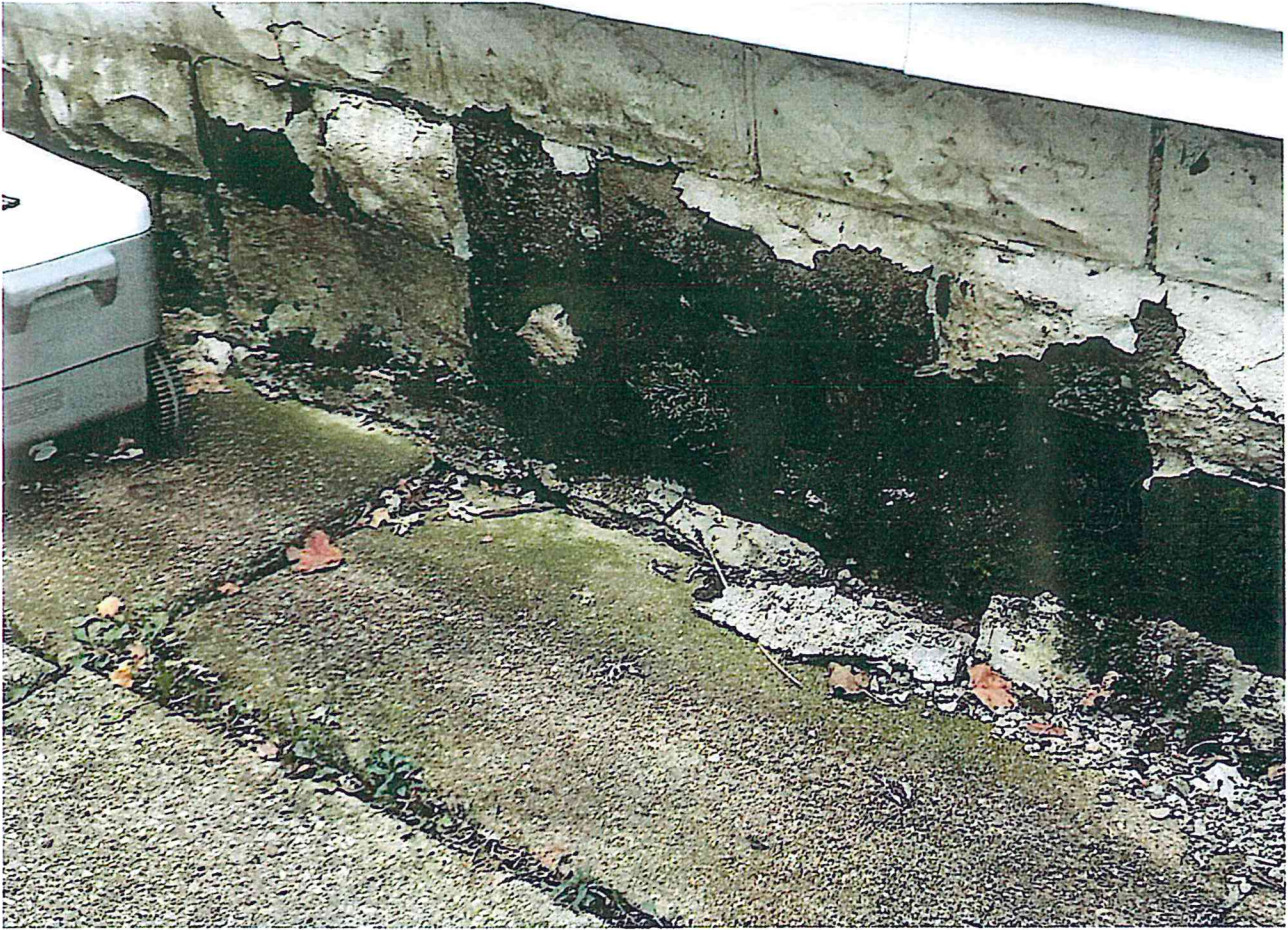
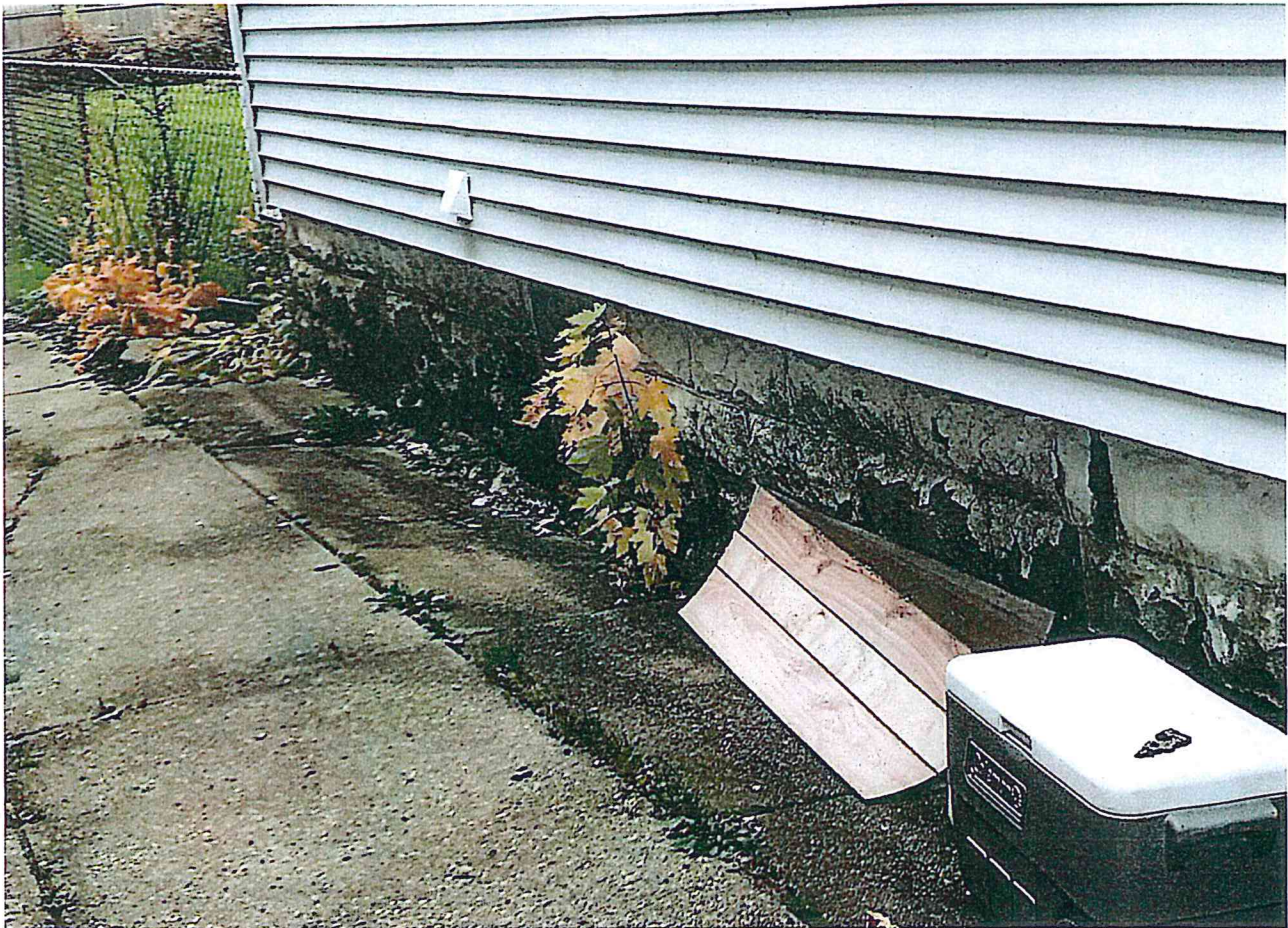
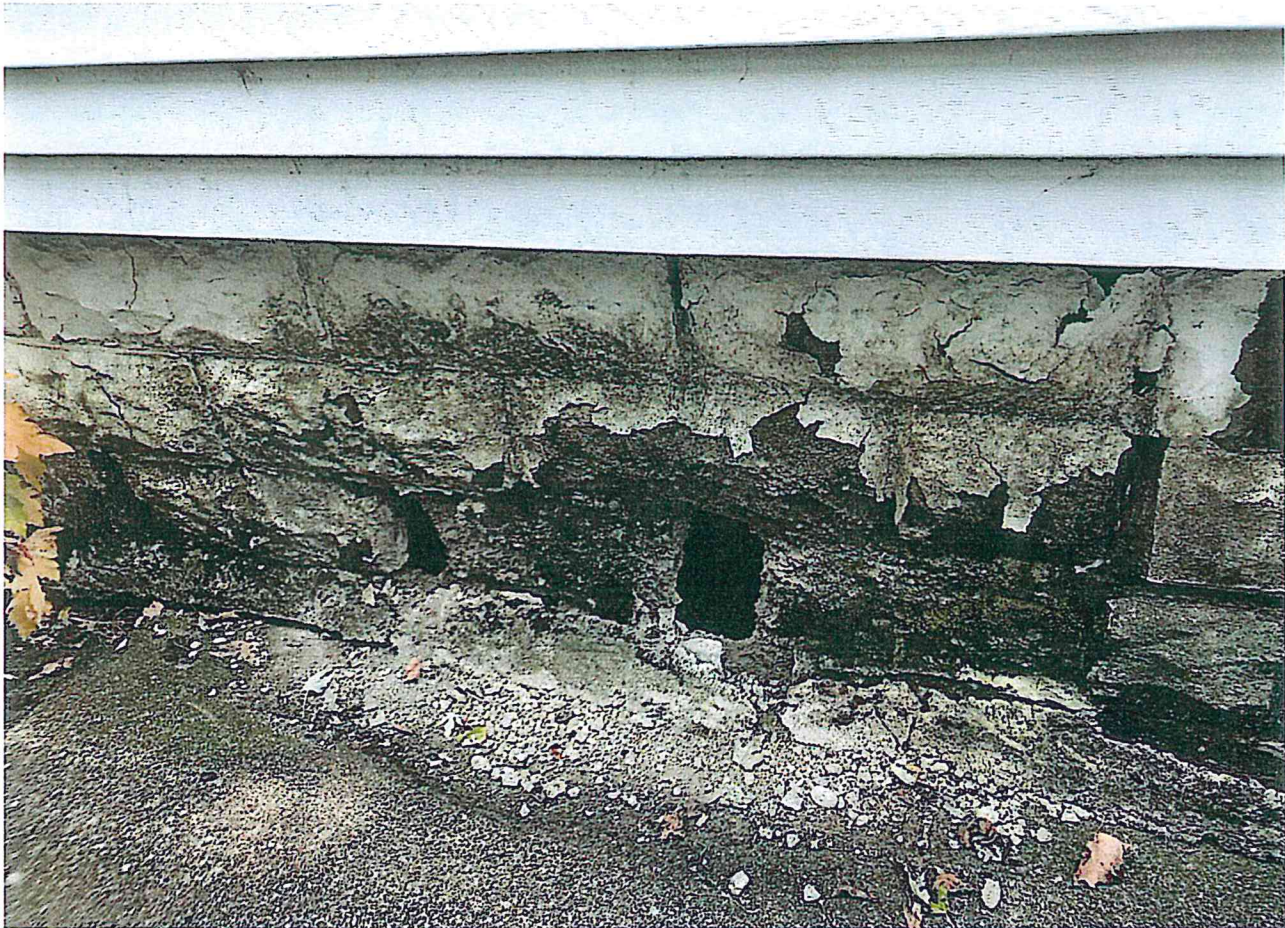
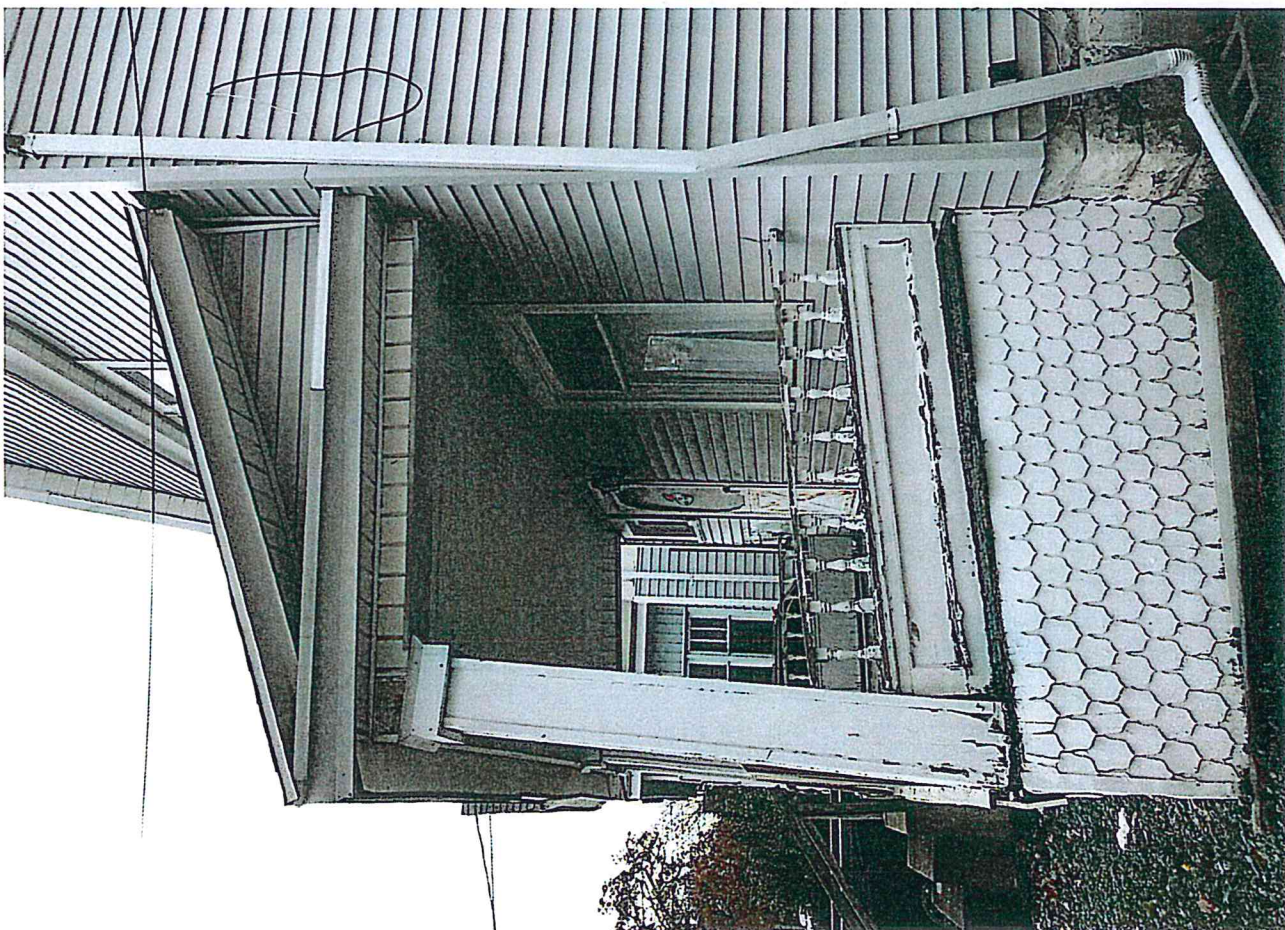
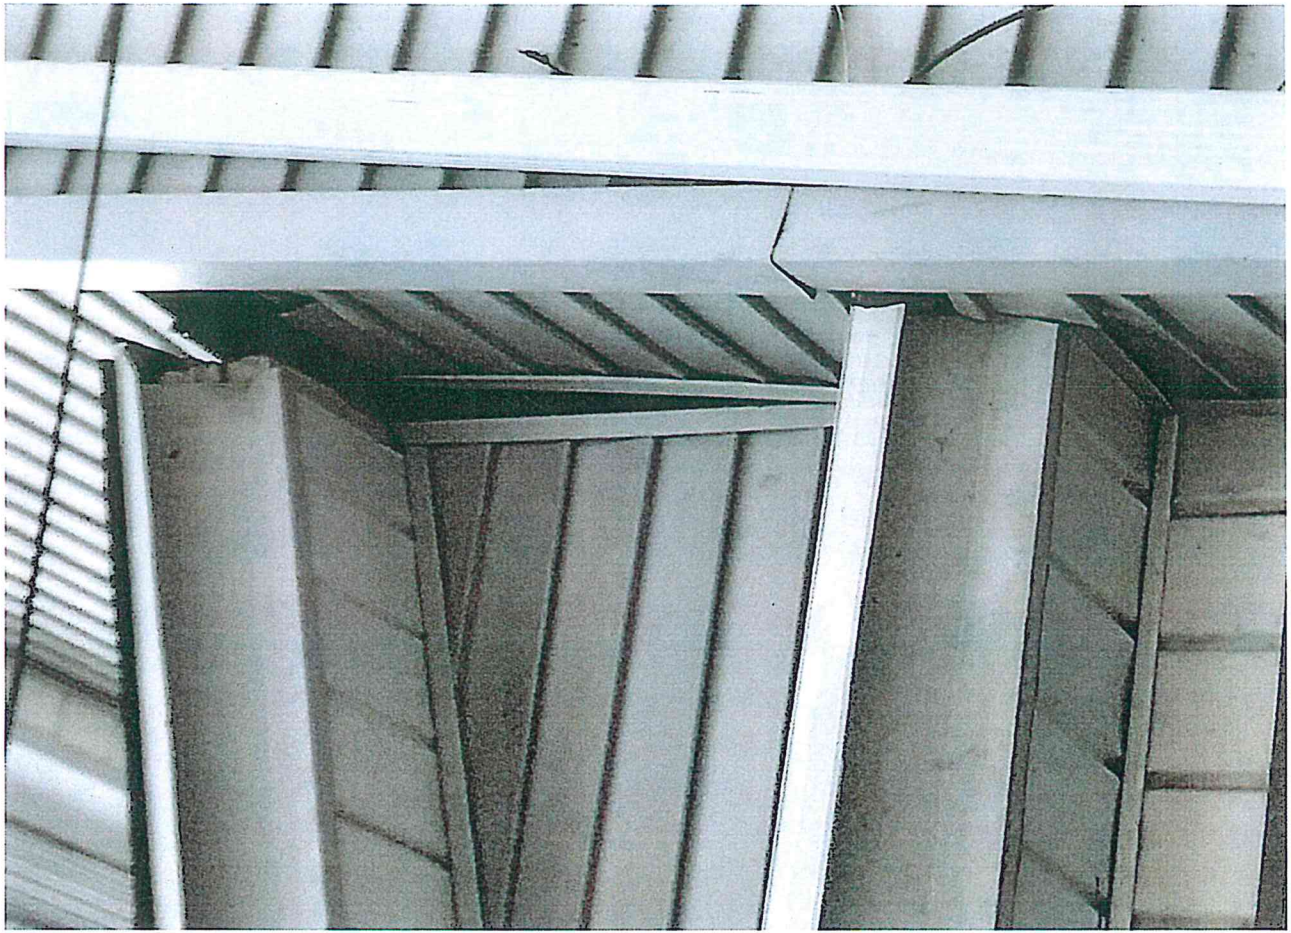
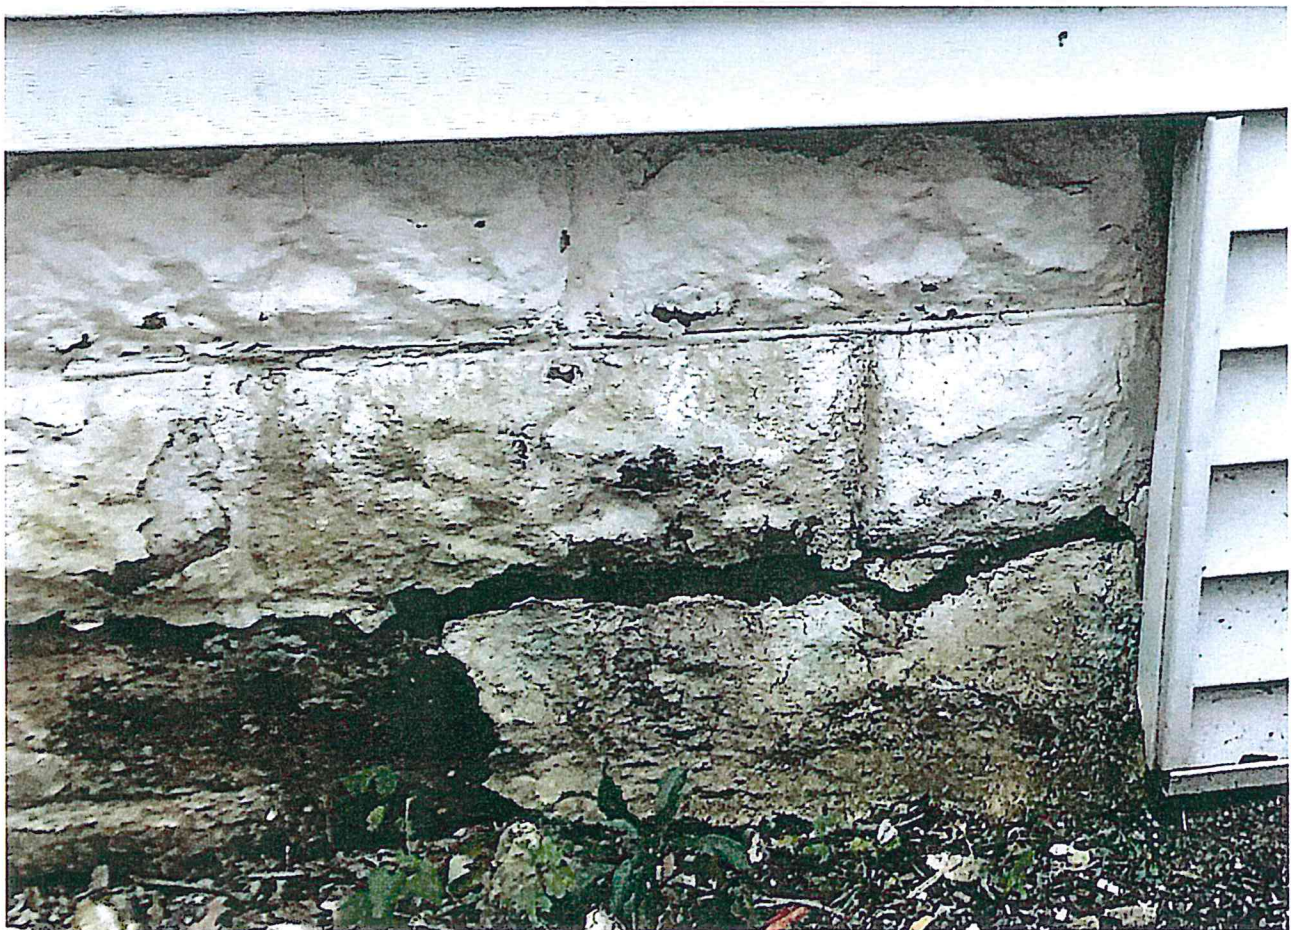
- 1) The house has been vacated almost approximately 2 years
- 2) Exposed wood requiring protection on both house and garage
- 3) The house was secured by this office days prior to this inspection

- 4) Roof shingles are deteriorated
- 5) Front porch has a structural defect – The top ledger is pulling away from the house and the front posts are pushing outward

- 6) The foundation wall on the North and South elevations is pushed in a considerable amount where the foundation meets the ground. The foundation has a copious amount of mortar joints missing as well. In short, we observed the house is shifting inward with the walls failing. The walls are revealing with a possible heavy snow fall it seems that collapse is imminent.

- 9) Downspouts are directed to the foundation walls
- 10) This is an attractive nuisance to the neighborhood
- 11) Obvious signs of vermin present
- 12) A copious amount of combustibles are present in the house

- 13) The chimney is deteriorated with bricks out of place and missing mortar in between.
- 14) The garage roof shows deterioration and weather coming in
