PROPOSED REPAIRS

BURCHFIELD NATURE & ART CENTER

2001 Union Road
West Seneca, NY 14224

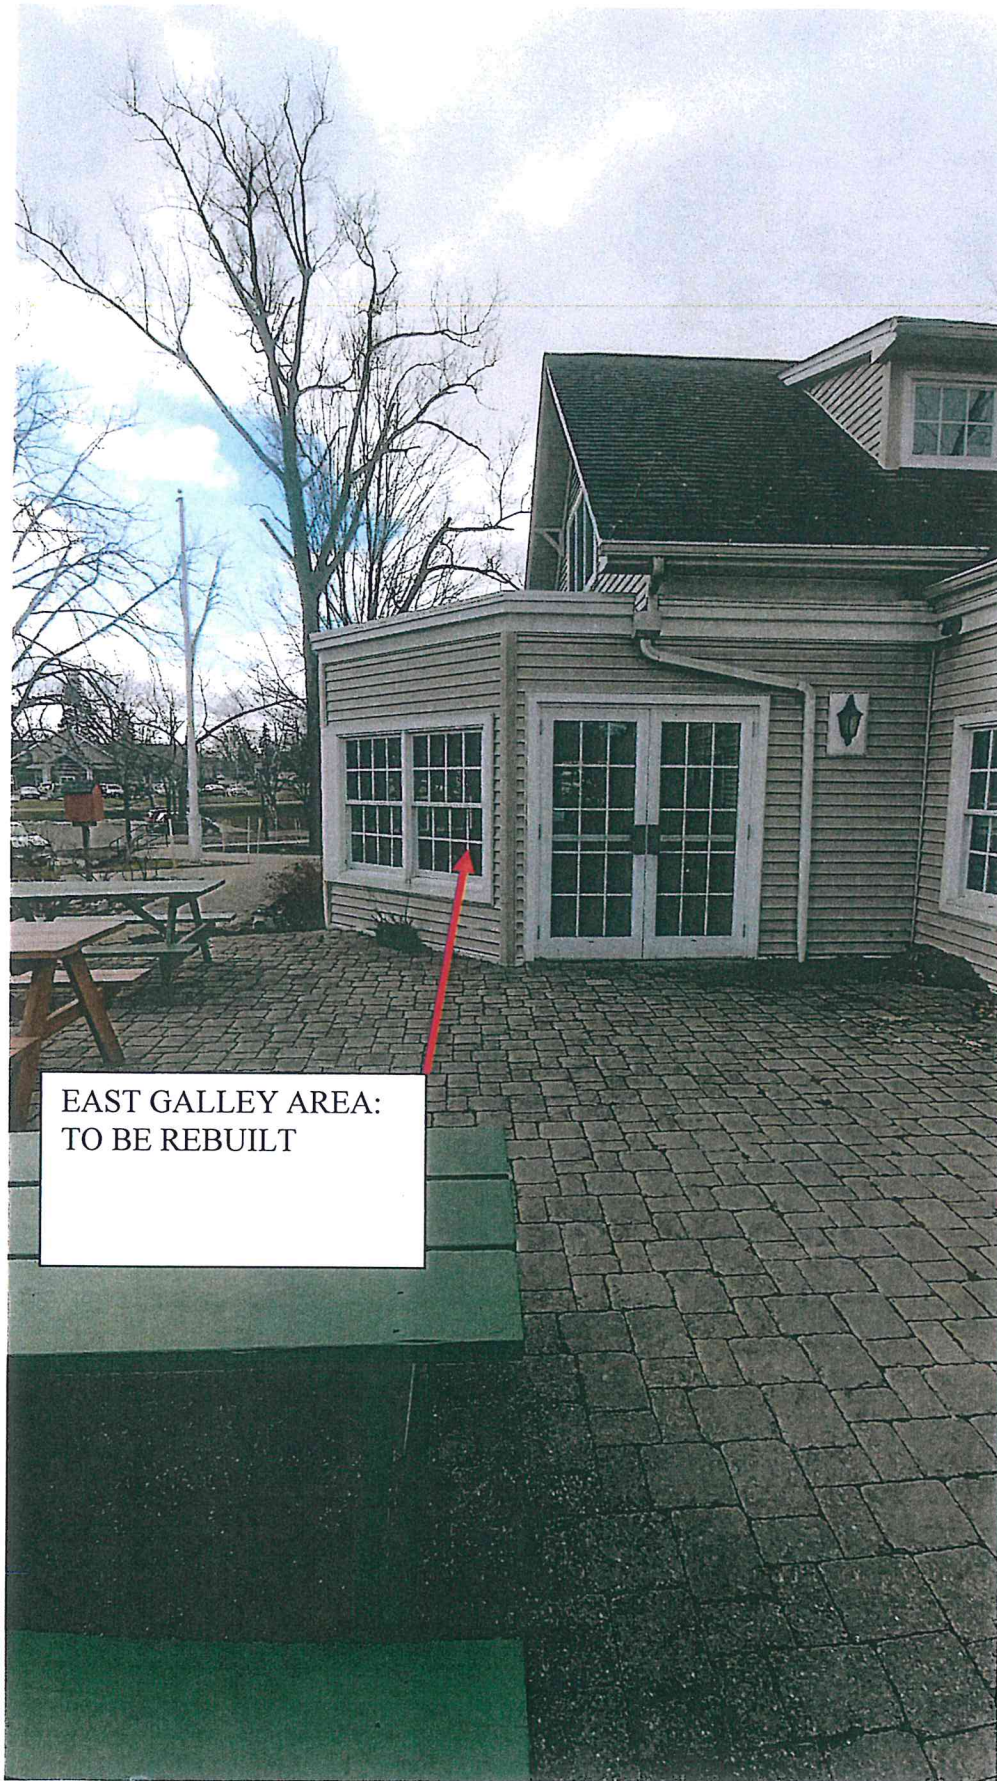
EAST GALLEY AREA:
TO BE REBUILT

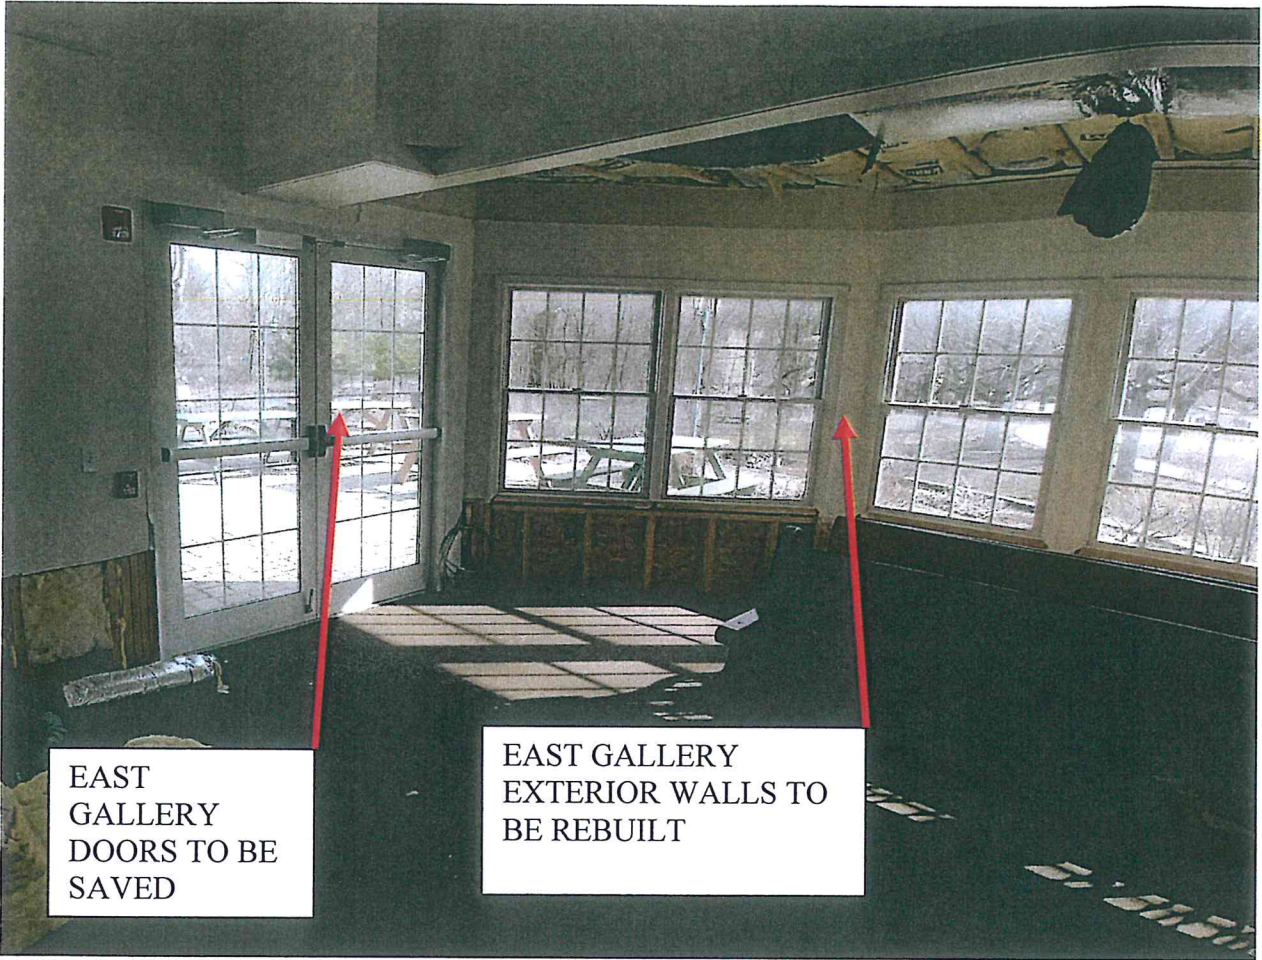
EAST
GALLERY
DOORS TO BE
SAVED

EAST GALLERY
EXTERIOR WALLS TO
BE REBUILT

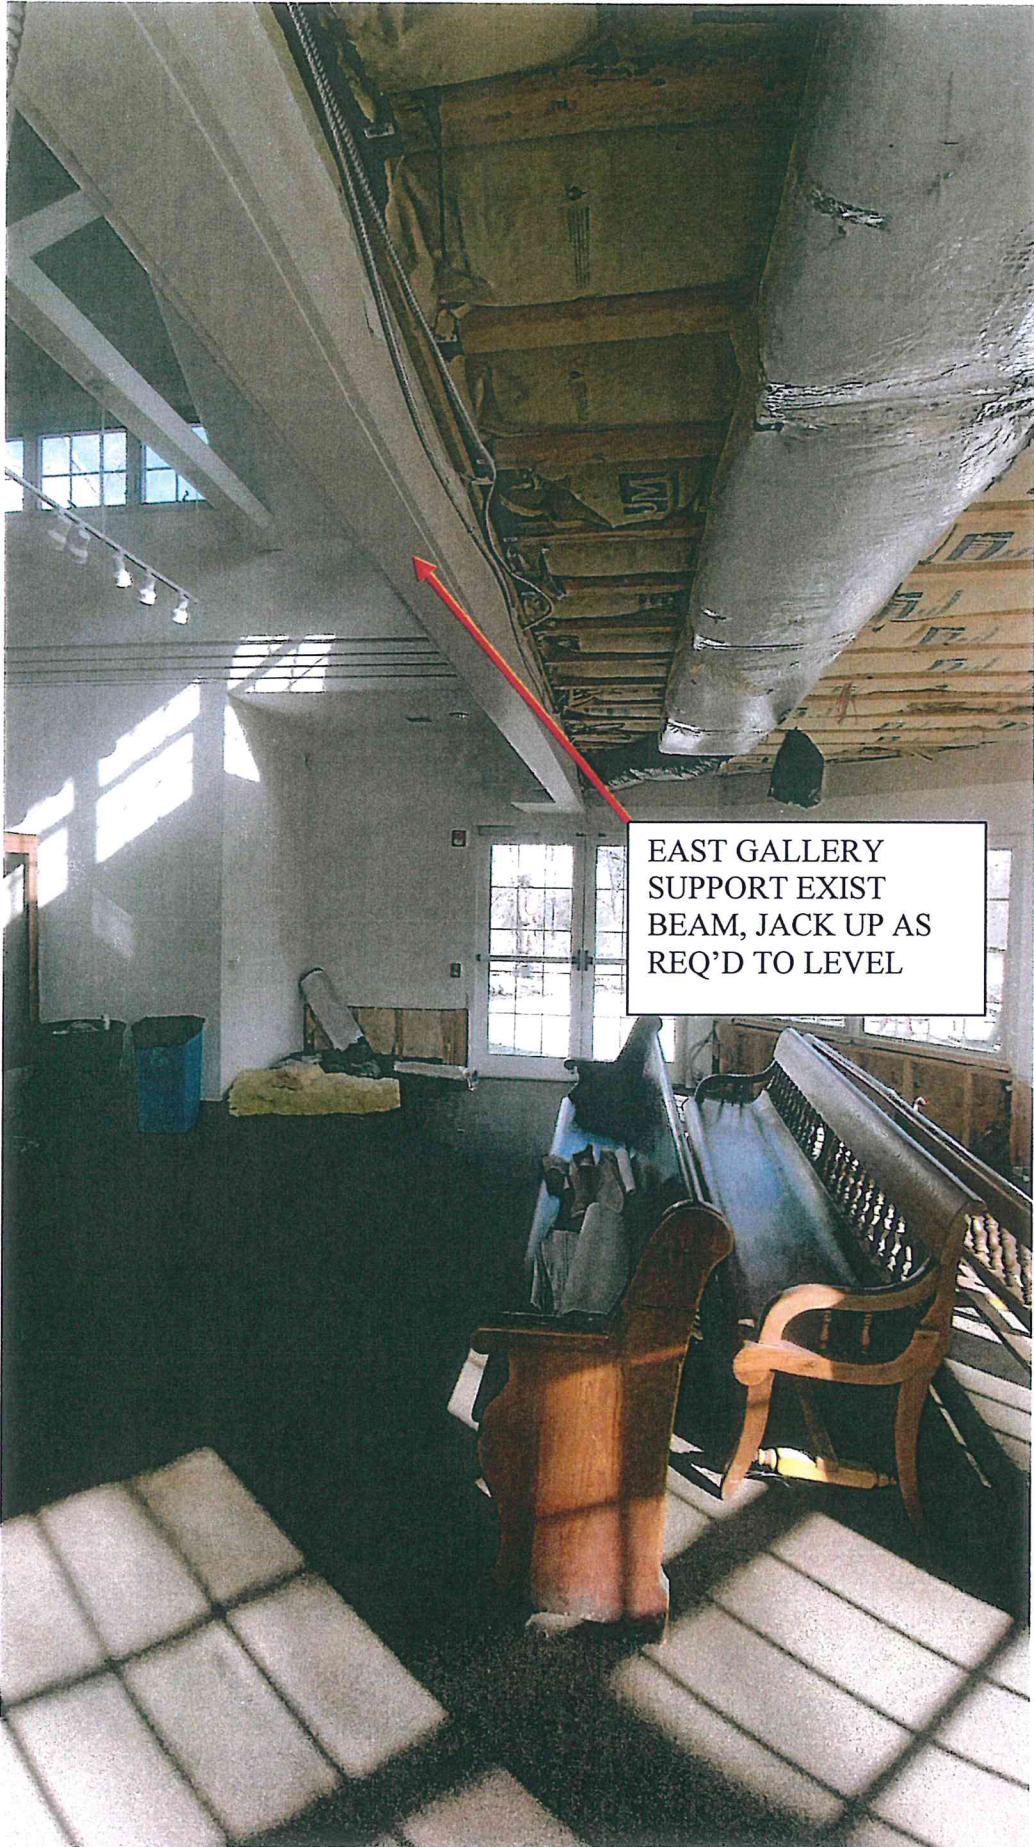
EAST GALLERY
SUPPORT EXIST
BEAM, JACK UP AS
REQ'D TO LEVEL

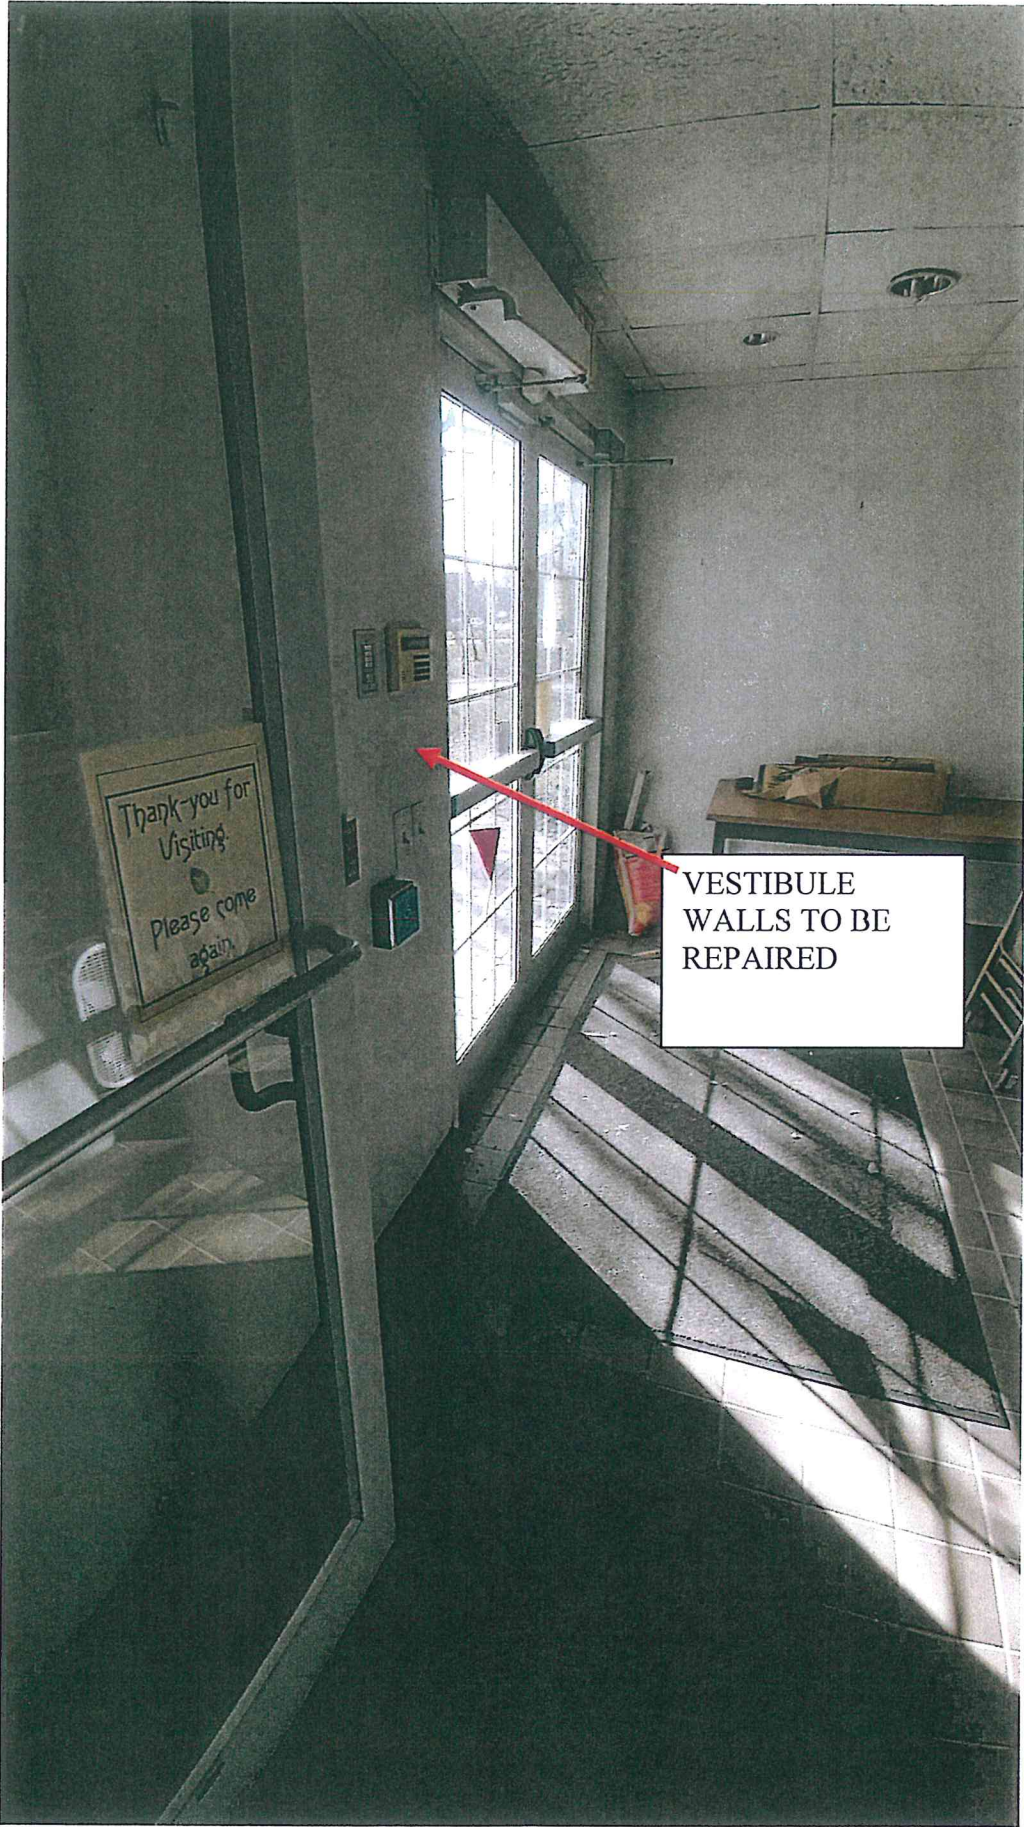
VESTIBULE
WALLS TO BE
REPAIRED

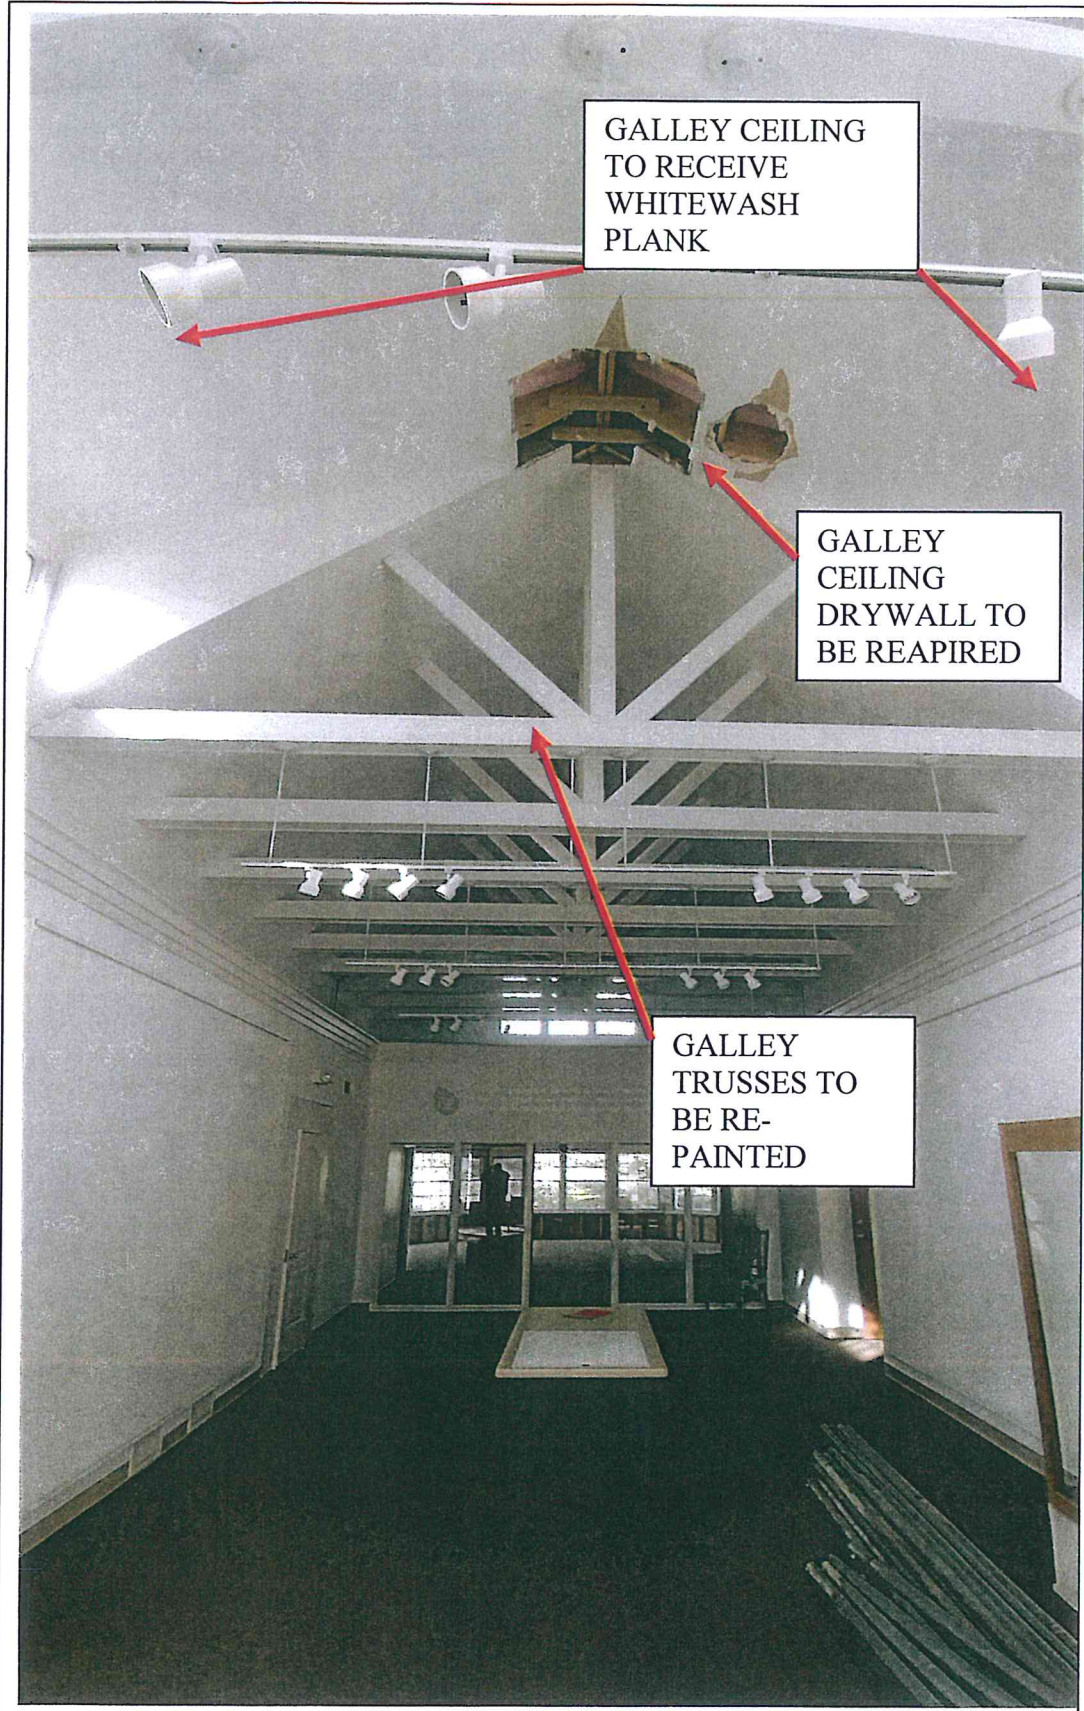
GALLEY CEILING
TO RECEIVE
WHITEWASH
PLANK

GALLEY
CEILING
DRYWALL TO
BE REAPIRED

GALLEY
TRUSSES TO
BE RE-
PAINTED

2. re-install batt insulation in roof framing where it was previously removed
3. ensure vapor barrier in place
4. re-install drywall in areas where previously removed
5. plaster & sand drywall patches
6. install whitewashed ship lap 1x wood board on ceiling of dormers
7. whitewashed trim to be installed @ all corners and as required
8. re-caulk around joints where existing decorative wood trusses meet drywall
9. repaint existing decorative wood trusses
10. repaint galley ceiling

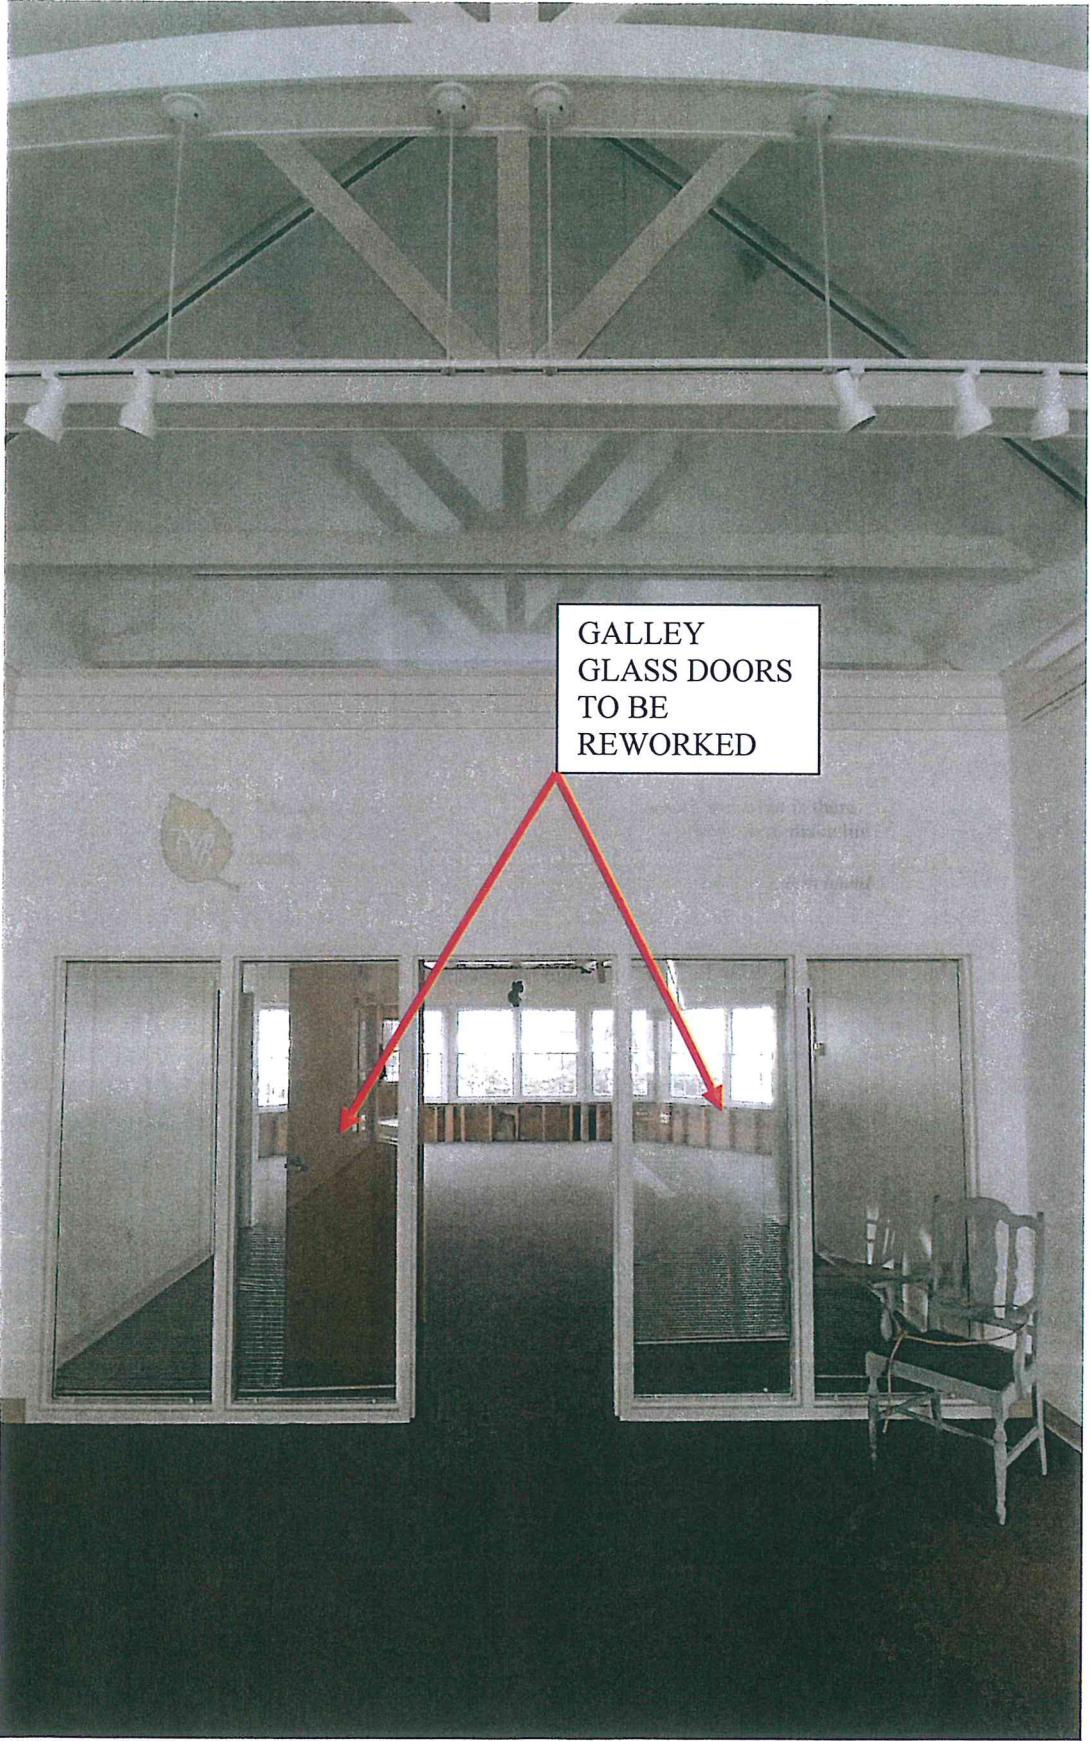
GALLEY
GLASS DOORS
TO BE
REWORKED

1. prep existing opening to accept new sliding doors & window
2. style and size of door to TBD
3. size and location of fixed pane glazing TBD

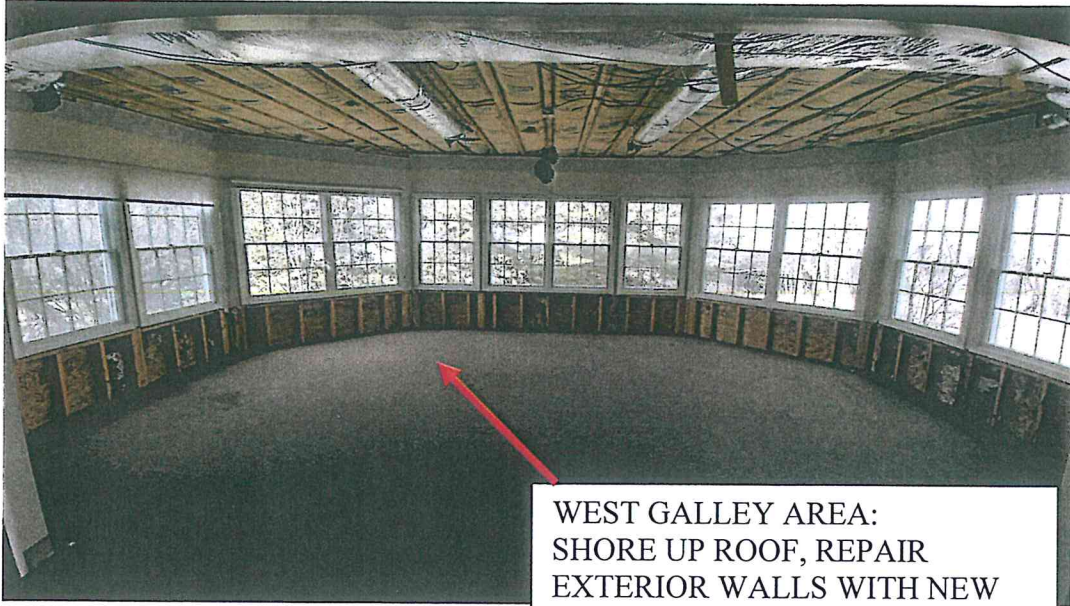
WEST GALLEY AREA:
SHORE UP ROOF, REPAIR
EXTERIOR WALLS WITH NEW
FRAMING & WINDOWS

1. install 2 courses of 4" cmu on existing foundation shelf. Install rebar pins and grout solid
2. build new 2x4 exterior wall on top of new cmu blocks
3. re-install windows or replace with new
4. exterior siding, as selected
5. batt insulation, vapor barrier & drywall
6. re-install electrical as determined
7. new ceiling lighting as determined
8. re-insulated ceiling to ensure adequate R value and proper vapor barrier installed
9. new 2x4 acoustical ceiling grid & tiles system
10. paint, carpet, trim
11. ROOF OPTIONS:
 - a. Existing roof to remain. Apply new rubberized coating over existing rubber roof.
 - b. Construct new wood framed gable style roof that would eliminate flat roof.

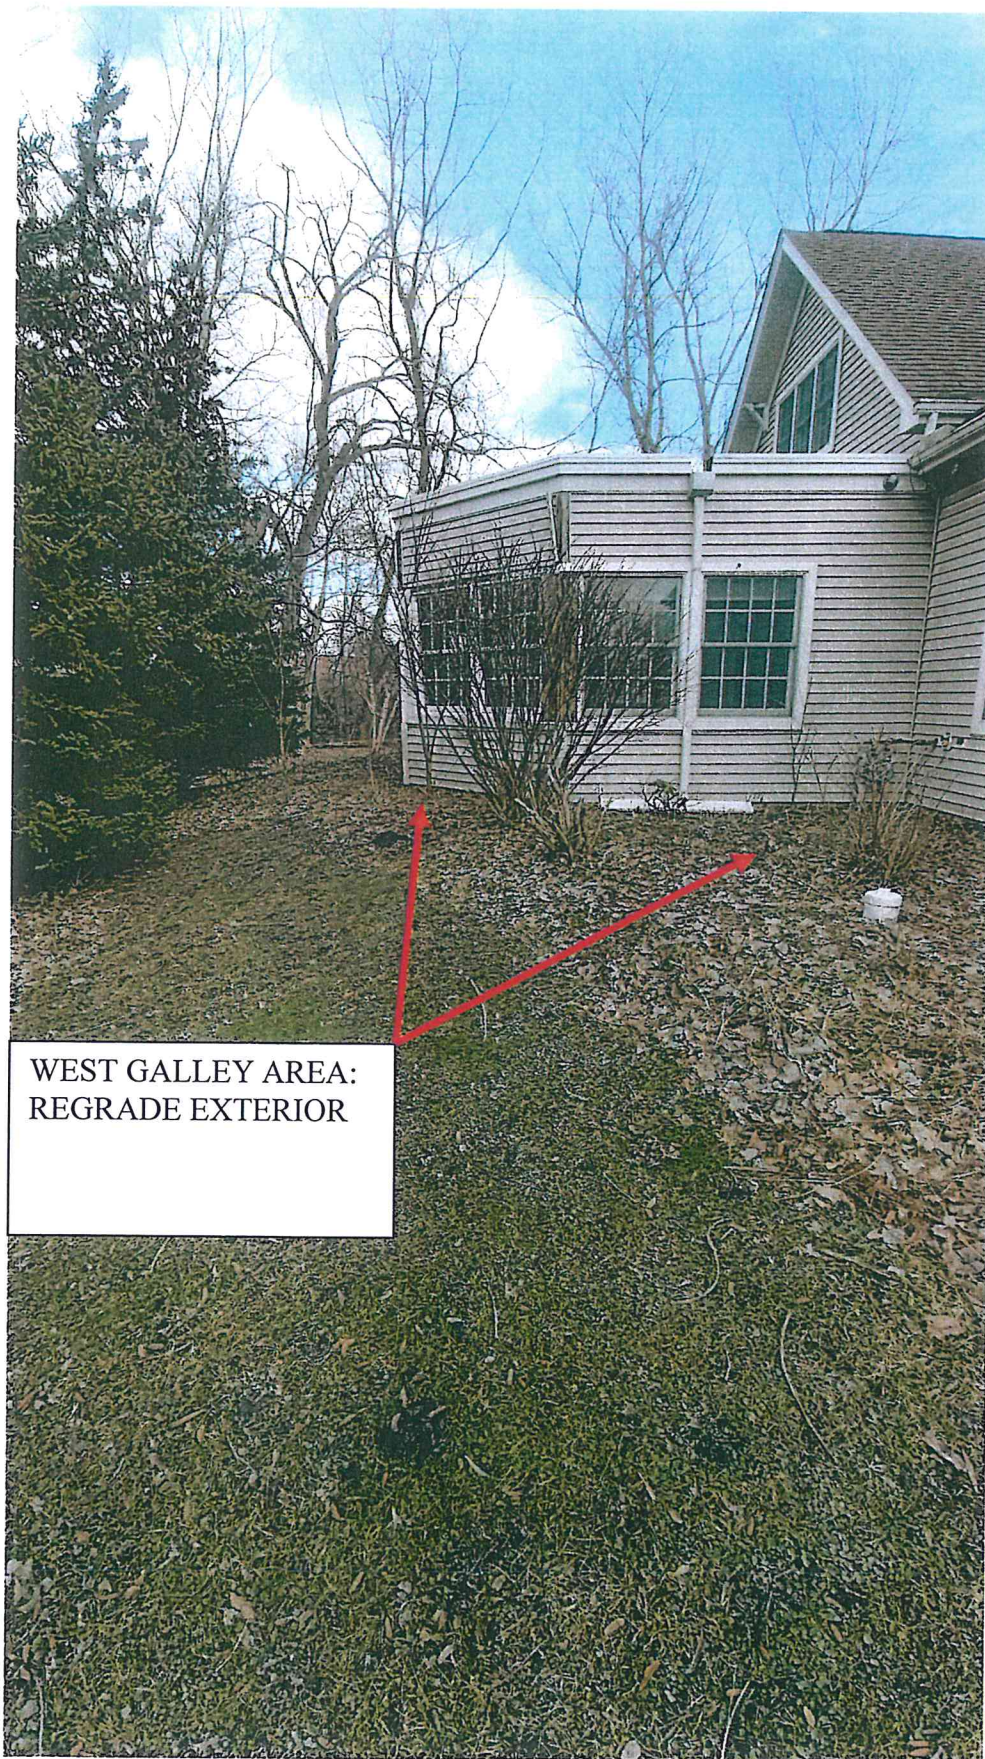
WEST GALLEY AREA:
REGRADE EXTERIOR

1. re-grade exterior of site along building on West side
2. remove approx 12" of earth around building
3. shore up existing roof framing
4. remove exterior walls and windows
5. save window for re-installation
6. Remove and cap electrical as required
7. remove and cap HVAC as required
8. remove and cap fire alarm devices as required

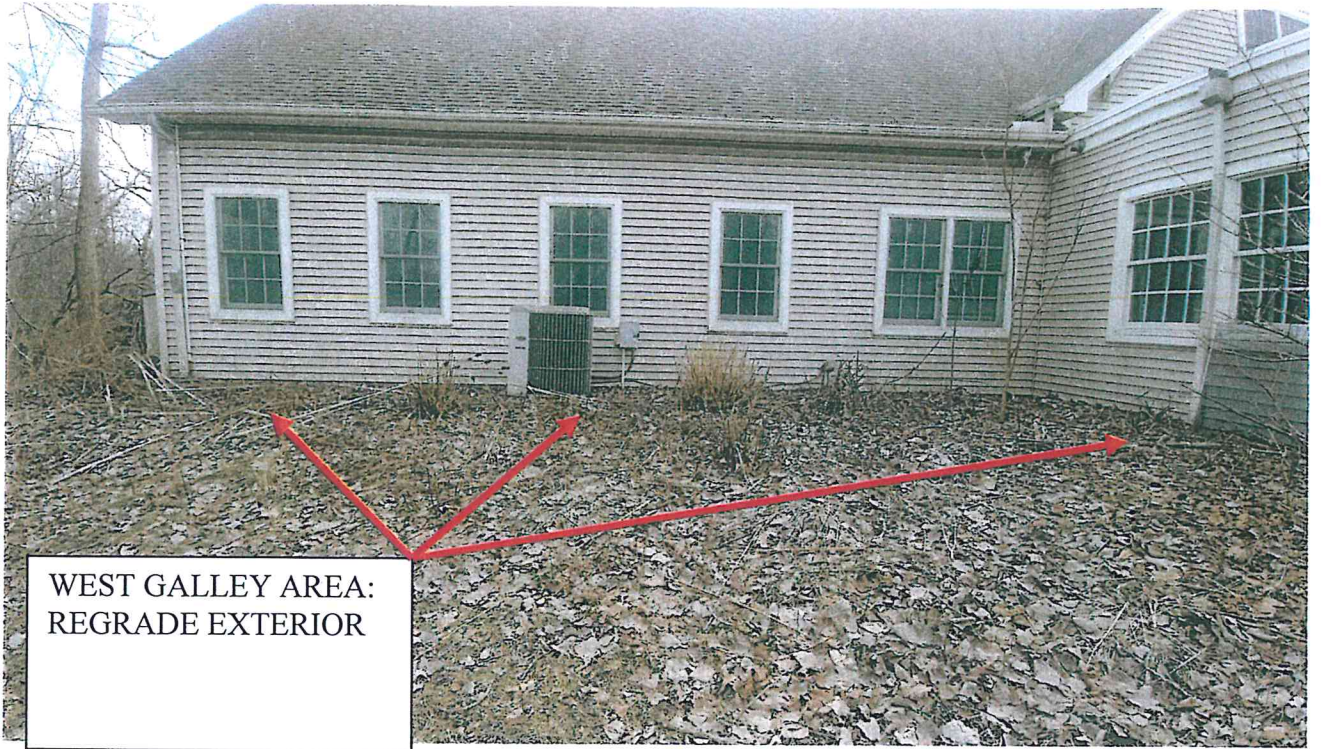
WEST GALLEY AREA:
REGRADE EXTERIOR
