NEW GARDENVILLE SUBSTATION PROJECT
TOWN OF WEST SENECA, ERIE COUNTY, NEW YORK
WETLAND & WATERCOURSE DELINEATION REPORT
UPDATE

UPDATE JANUARY 2020

180 CHARLOTTE STREET
ROCHESTER, NY 14624
FISHER ASSOCIATES PROJECT No. 185057.00

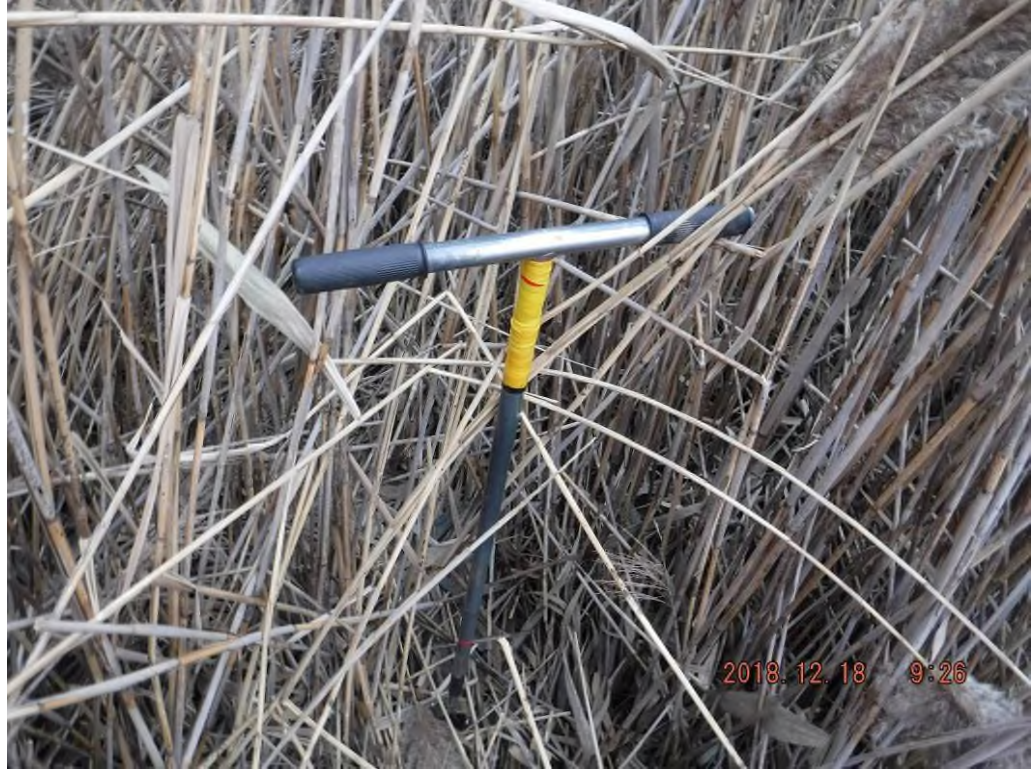
Photo No. 01
Facing North
Description: Data Point 001 PEM Data Point for PEM Wetland 001. When: December 18, 2018

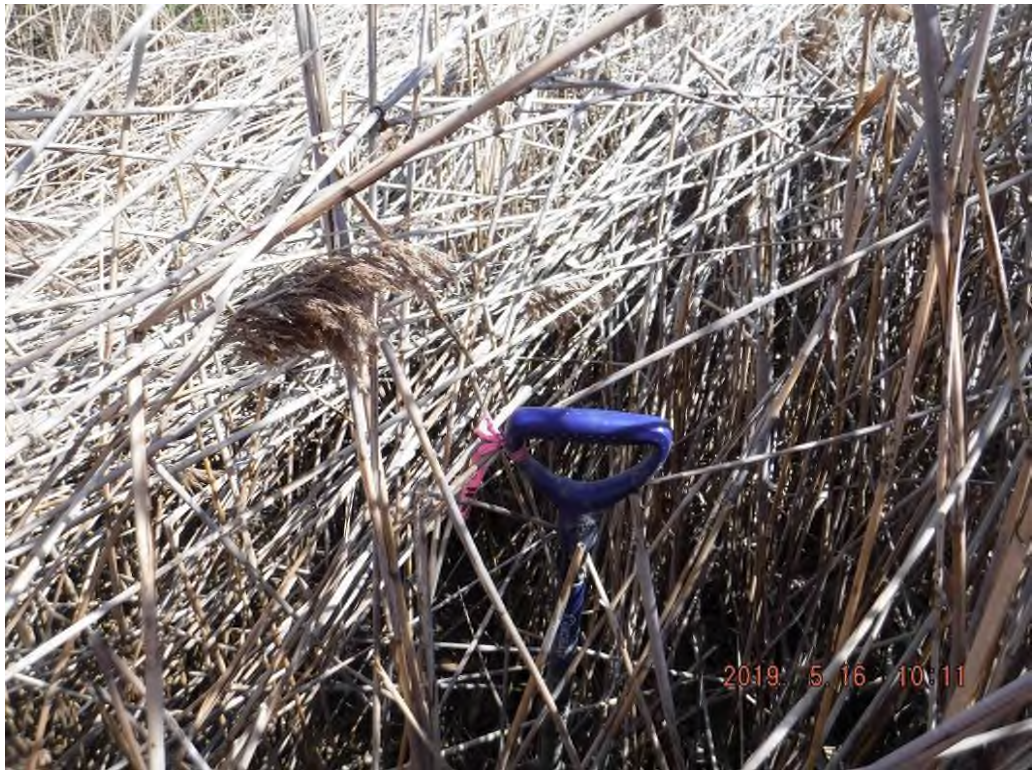
Photo No. 02
Facing North
Description: Data Point 001 Overview of PEM Wetland 001. When: May 16, 2019

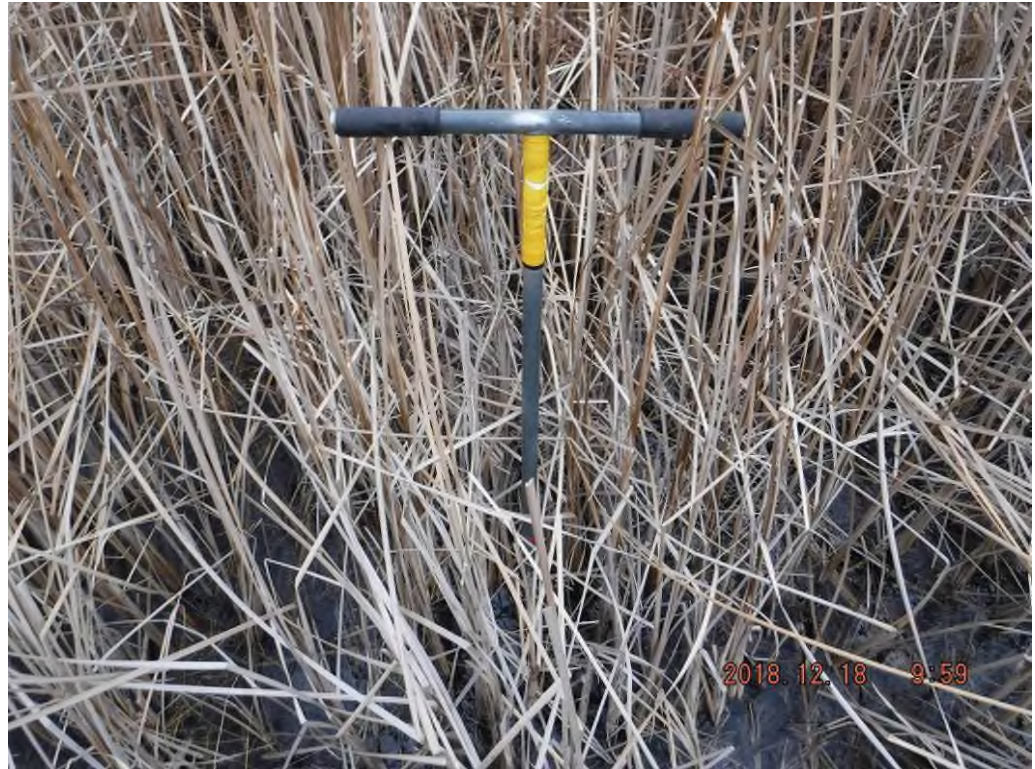
Data Point 003
PEM Data Point for
Wetland 002.

When:
December 18, 2018

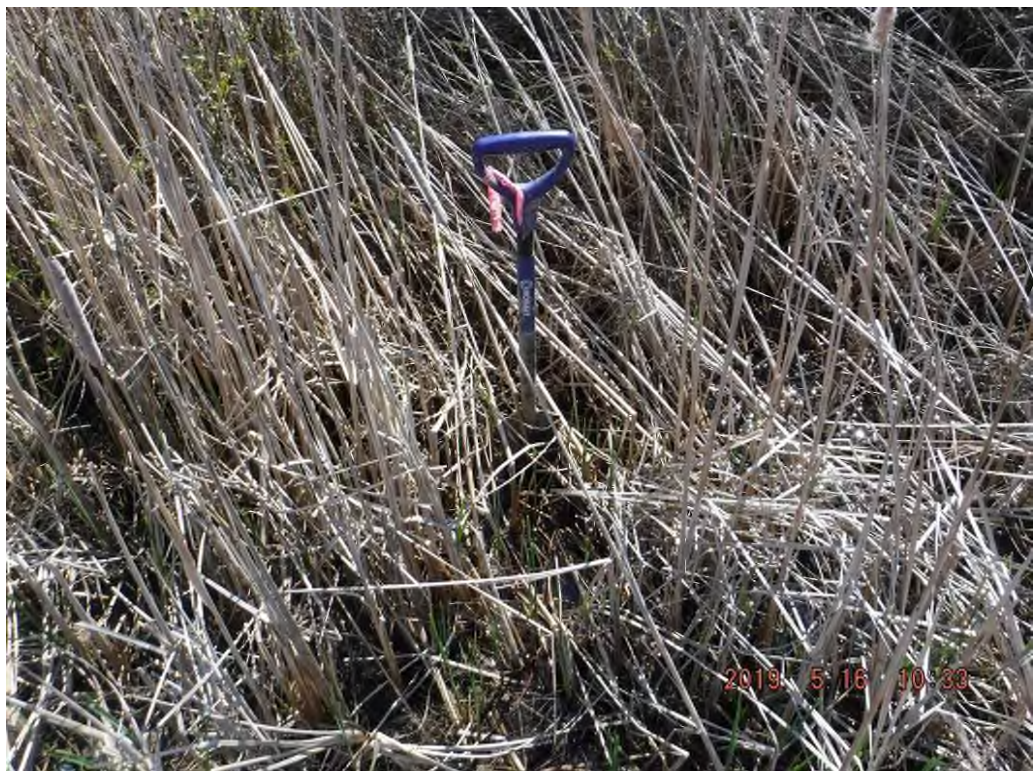
Photo No. 10

Data Point 003
PEM Data Point for
Wetland 002.

When:
May 16, 2019

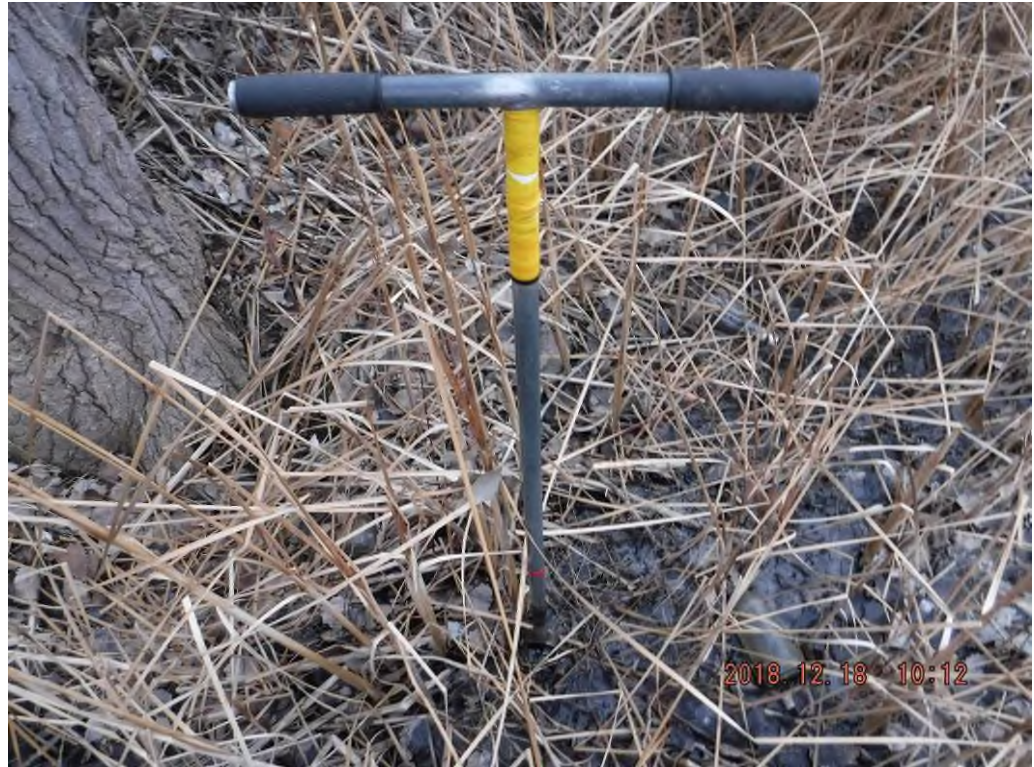
Photo No. 14

Facing North

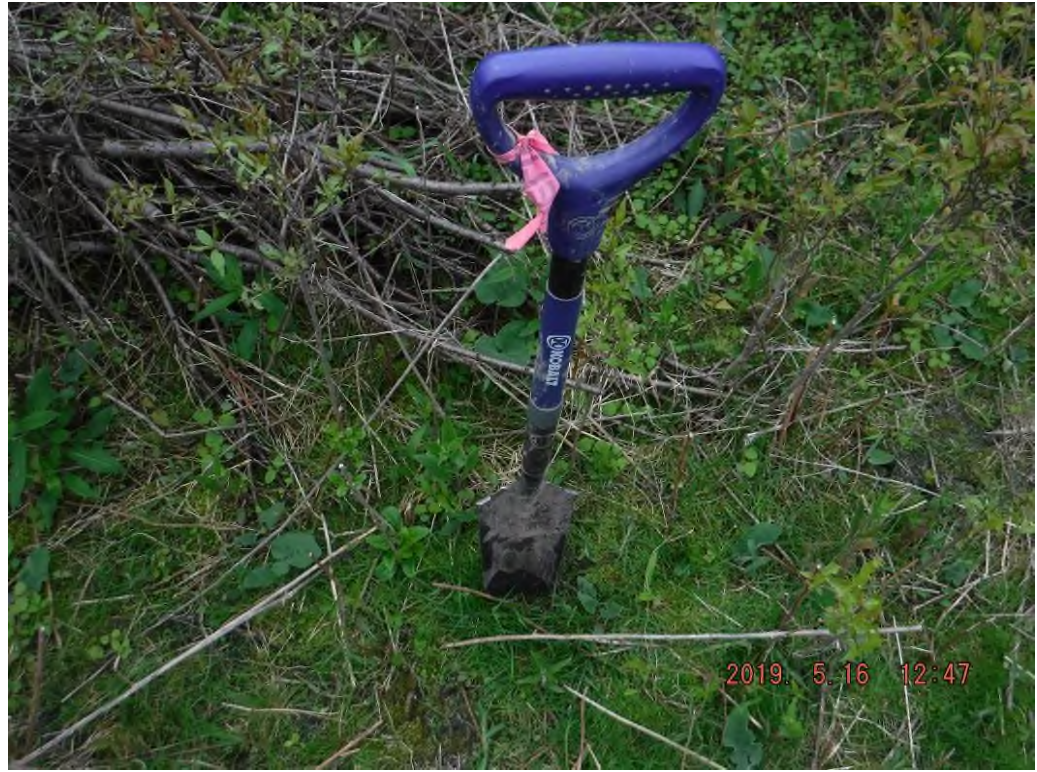
<p>Photo No. 47</p>
<p>Facing South</p>
<p>Description: Data Point 012 Upland/ dryland Data Point located on the south side of Stream 001. Area is raised up in comparison to Wetland 003, with a mix of vegetation by no hydric soils or wetland hydrology.</p> <p>When: May 16, 2019</p>

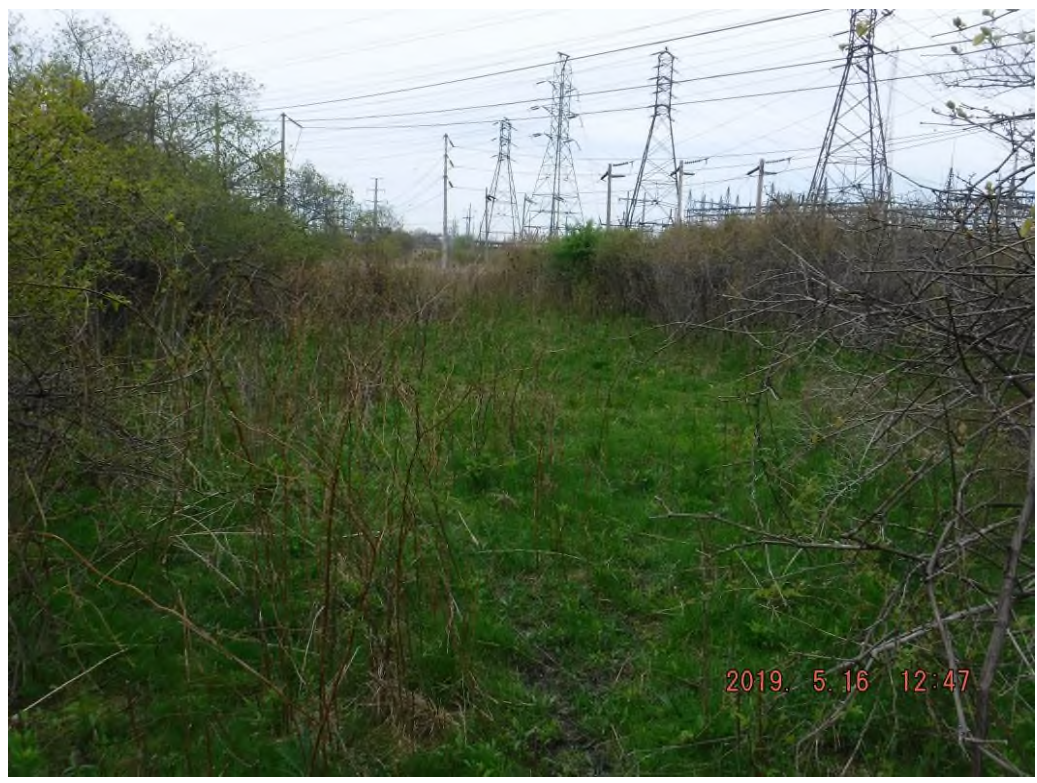
<p>Photo No. 48</p>
<p>Facing East</p>
<p>Description: Data Point 012 Upland/ dryland Data Point located on the south side of Stream 001. Area is raised up in comparison to Wetland 003, with a mix of vegetation by no hydric soils or wetland hydrology.</p> <p>When: May 16, 2019</p>
