Wetland and Waterbodies Delineation Report

NORTH AMERICA PARK

**Town of West Seneca
Erie County, New York**

**REPORT SUMMARIZING
THE RESULTS OF
A WETLAND DELINEATION SURVEY OF**

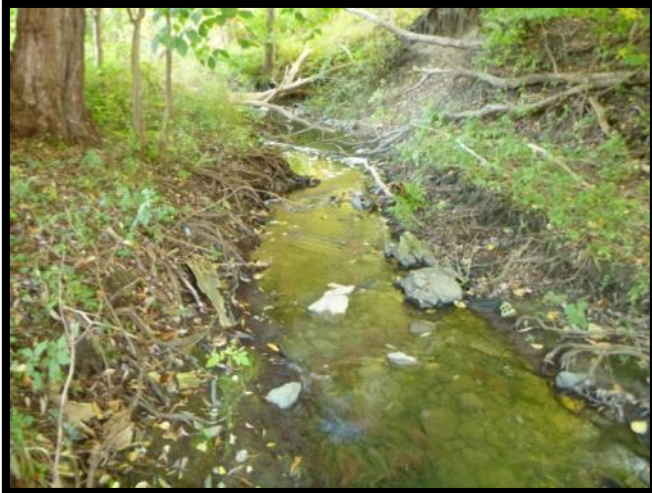
Photo 1: Facing north. Depicts Stream 1 flowing north in the eastern portion of the site.

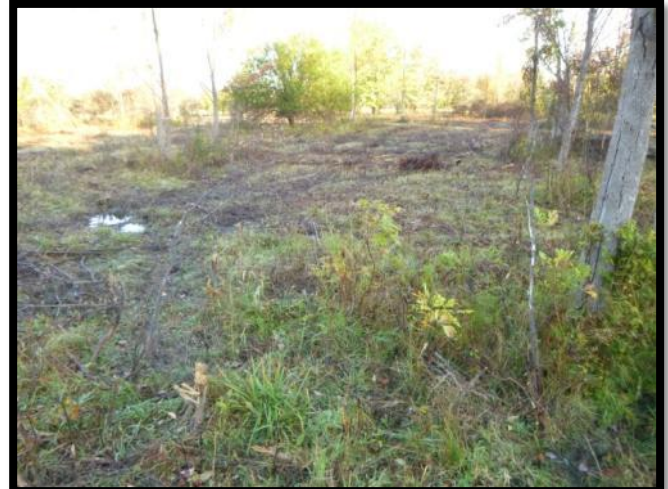
Photo 4: Facing north. Depicts the scrub-shrub community of wetland W1 at data point D3.

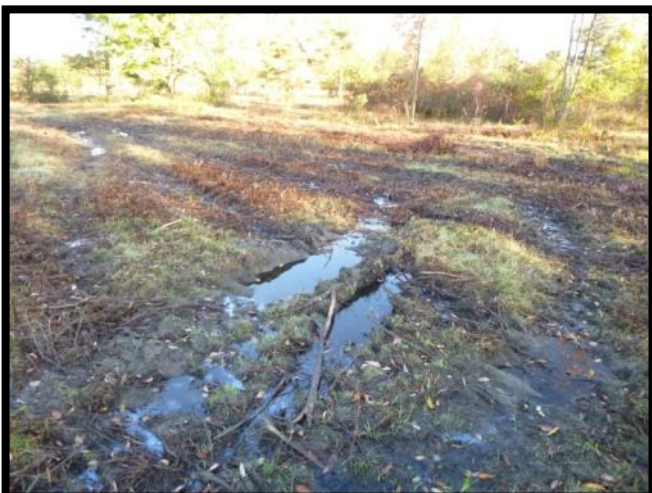
Photo 5: Facing north. Depicts the scrub-shrub community of wetland W2 at data point D4.

Wetland W2 is a 0.14± acre scrub-shrub swamp dominated by green ash (*Fraxinus americana*), gray dogwood (*Cornus racemosa*) and creeping bentgrass (*Agrostis stolonifera*). Soils within wetland W2 are mapped as Cayuga Silt Loam and had a topsoil color of 10YR3/1 with 2% 10YR5/8 mottles and a subsoil color of 10YR5/1 with 3% 10YR5/8 mottles. The texture is silt loam. This soil fits the NRCS F3 indicator (Depleted Matrix). Hydrology indicators present in Wetland W2 included surface water (A1), high water table (A2), saturation (A3) and water-stained leaves (B9). It is EDI's professional opinion that Wetland W2 is Federally non-jurisdictional due to the lack of connectivity to a traditionally navigable water.

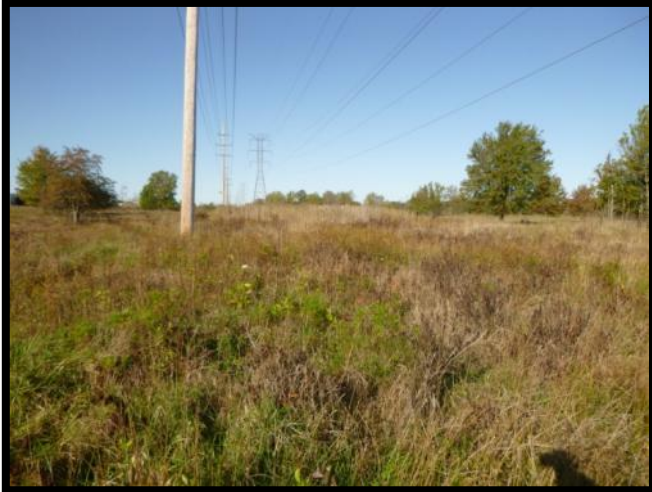
Photo 7: Facing west. Depicts the emergent marsh community of wetland W3 at data point D6.

stained leaves (B9). It is EDI's professional opinion that Wetland W3 is Federally jurisdictional due to the apparent off-site connectivity to Buffalo Creek, a traditionally navigable water.

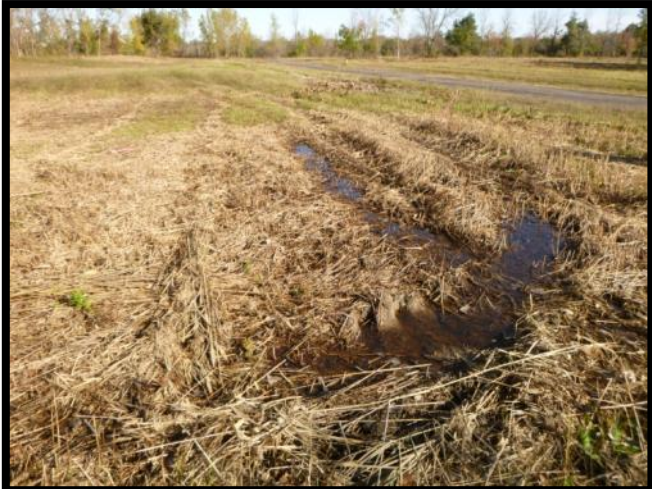
Photo 9: Facing north. Depicts the invasive species marsh community of wetland W4 at data point D8.

Wetland W4 is a 0.01± acre emergent (Invasive Species) marsh dominated by common reed (*Phragmites australis*). Soils within wetland W4 are mapped as Niagara Silt Loam and had a topsoil color of 10YR3/1 with 5% 10YR5/8 mottles and a subsoil color of 10YR6/1 with 10% 10YR5/8 mottles. The texture is silt loam. This soil fits the NRCS F3 indicator (Depleted Matrix). Hydrology indicators present in Wetland W4 included surface water (A1), high water table (A2), saturation (A3) and water-stained leaves (B9). It is EDI's professional opinion that Wetland W4 is Federally non-jurisdictional due to the lack of connectivity to a traditionally navigable water.

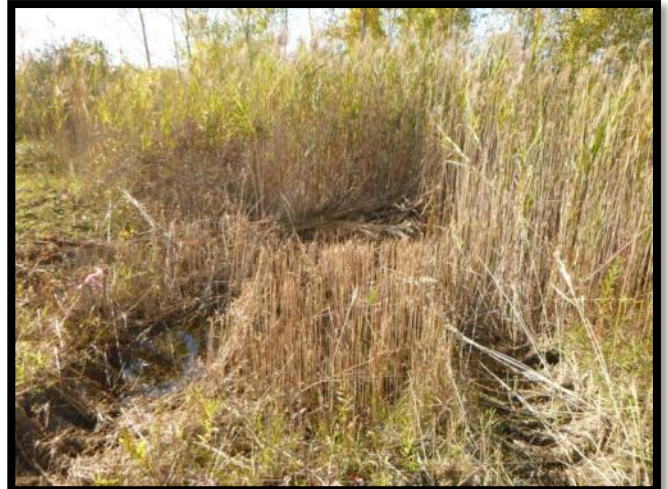
Photo 10: Facing south. Depicts the invasive species marsh community of wetland W5 at data point D9.

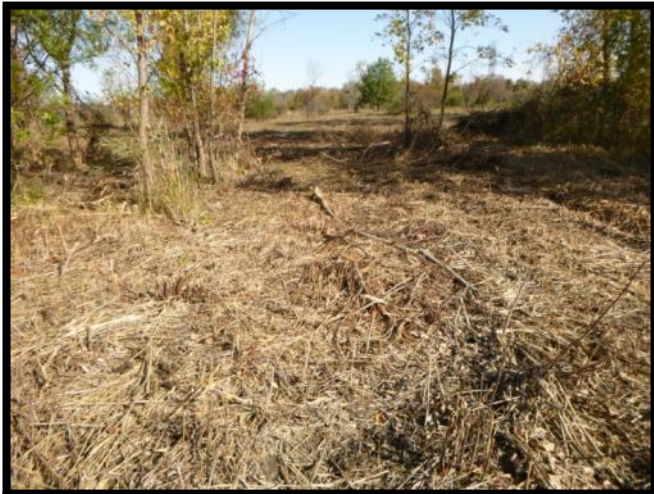
Photo 13: Facing north. Depicts the scrub-shrub community of wetland W6 at data point D12.

Wetland W6 is a 0.11± acre scrub-shrub swamp dominated by eastern cottonwood (*Populus deltoides*), pussy willow (*Salix discolor*) and purple loosestrife (*Lythrum salicaria*). Soils within wetland W6 are mapped as Cayuga Silt Loam and had a soil color of 10YR3/1 with 2% 10YR5/8 mottles. The texture is silt loam. This soil fits the NRCS F6 indicator (Redox Dark Surface). Hydrology indicators present in Wetland W6 included saturation (A3) and water-stained leaves (B9). It is EDI's professional opinion that Wetland W6 is Federally non-jurisdictional due to the lack of connectivity to a traditionally navigable water.

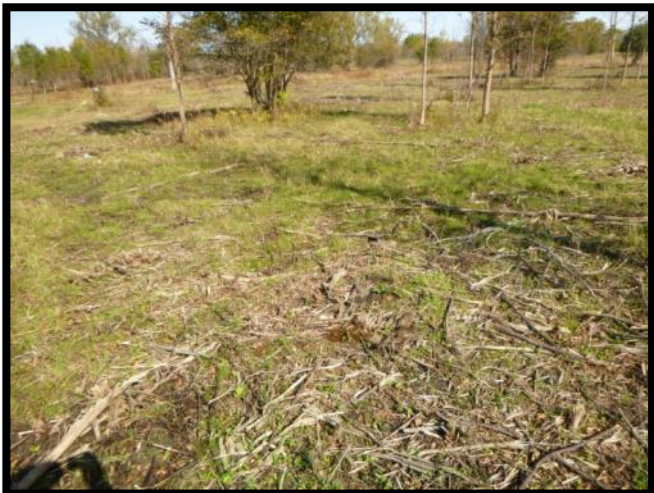
Photo 15: Facing north. Depicts the scrub-shrub community of wetland W7 at data point D14.

Wetland W7 is a 2.94± acre scrub-shrub swamp dominated by green ash (*Fraxinus pennsylvanica*), gray dogwood (*Cornus racemosa*), pussy willow (*Salix discolor*), creeping bentgrass (*Agrostis stolonifera*) and sensitive fern (*Onoclea sensibilis*). Soils within wetland W7 are mapped as Cayuga Silt Loam and had a soil color of 10YR4/1 with 5% 10YR5/8 mottles. The texture is silt loam. This soil fits the NRCS F6 indicator (Redox Dark Surface). Hydrology indicators present in Wetland W7 included high water table (A2), saturation (A3) and water-stained leaves (B9). It is EDI's

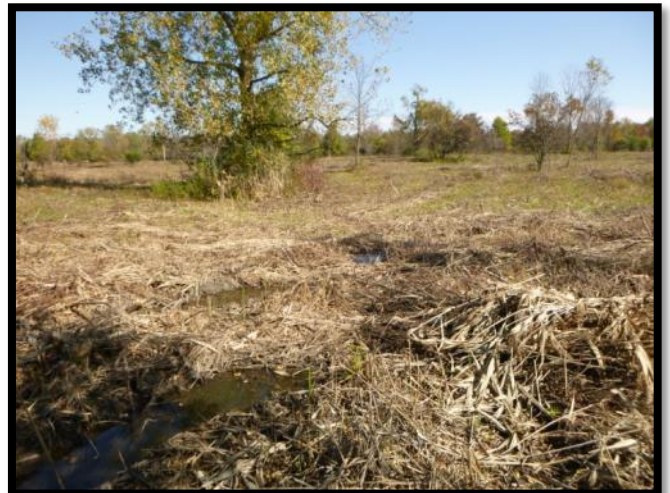
Photo 16: Facing north. Depicts the emergent marsh community of wetland W8 at data point D15.

Wetland W8 is a 0.32± acre emergent marsh dominated by pussy willow (*Salix discolor*) and common reed (*Phragmites australis*). Soils within wetland W8 are mapped as Cayuga Silt Loam and had a topsoil color of 10YR3/1 with 3% 10YR5/8 mottles and a subsoil color of 10YR5/1 with 5% 10YR5/8 mottles. The texture is silt loam. This soil fits the NRCS F3 indicator (Depleted Matrix). Hydrology indicators present in Wetland W8 included surface water (A1), high water table (A2), saturation (A3) and water-stained leaves (B9). It is EDI's professional opinion that Wetland W8 is Federally non-jurisdictional due to the lack of connectivity to a traditionally navigable water.

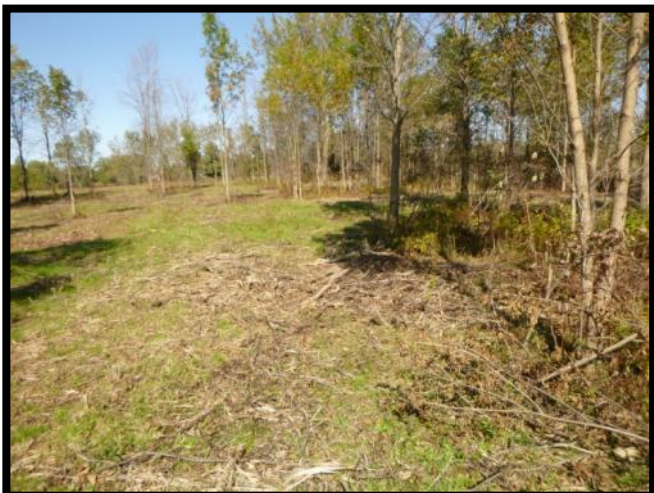
Photo 17: Facing north. Depicts the scrub-shrub community of wetland W9 at data point D16.

Wetland W9 is a 2.68± acre scrub-shrub swamp dominated by green ash (*Fraxinus pennsylvanica*), gray dogwood (*Cornus racemosa*), tall hairy agrimony (*Agrimonia gryposepala*) and sensitive fern (*Onoclea sensibilis*). Soils within wetland W9 are mapped as Canandaigua Silt Loam and had a soil color of 10YR3/1 with 3% 10YR5/8 mottles. The texture is silt loam. This soil fits the NRCS F6 indicator (Redox Dark Surface). Hydrology indicators present in Wetland W9 included high water table (A2), saturation (A3) and water-stained leaves (B9). It is EDI's professional opinion that Wetland W9 is Federally jurisdictional due to the apparent off-site connectivity to Buffalo Creek, a traditionally navigable water.

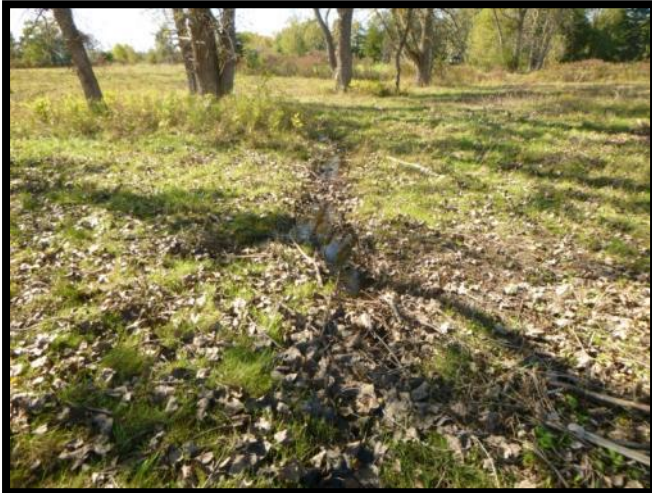
Photo 19: Facing west. Depicts Stream 2 flowing west from the site.

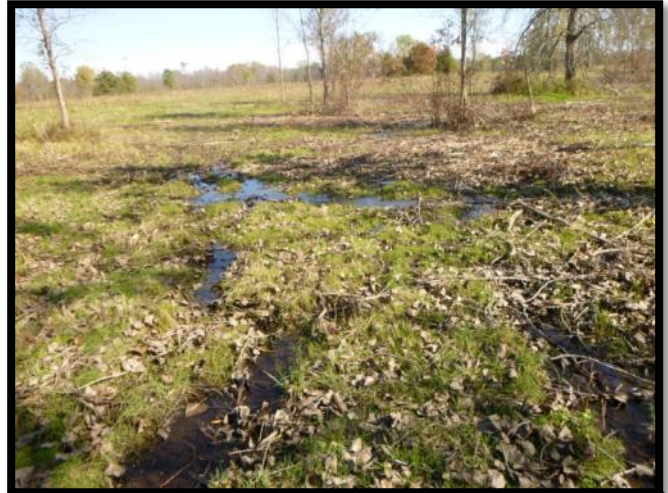
Photo 20: Facing east. Depicts the scrub-shrub swamp community of wetland W10 at data point D18.

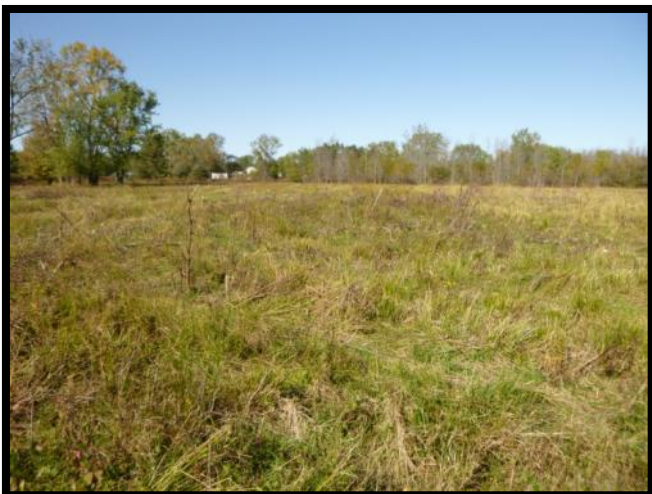
Photo 21: Facing north. Depicts the scrub-shrub swamp community of wetland W11 at data point D19.

color of 10YR3/1 with 3% 10YR5/8 mottles and a subsoil color of 10YR6/1 with 20% 10YR5/6 mottles. The texture is silt loam. This soil fits the NRCS F3 indicator (Depleted Matrix). Hydrology indicators present in Wetland W11 included high water table (A2), saturation (A3) and water-stained leaves (B9). It is EDI's professional opinion that Wetland W11 is Federally jurisdictional due to the apparent off-site connectivity to Buffalo Creek, a traditionally navigable water.

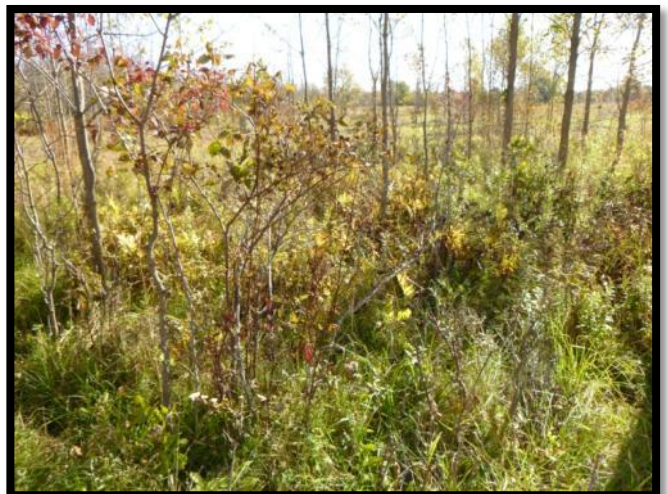
Photo 22: Facing east. Depicts the scrub-shrub swamp community of wetland W12 at data point D20.

Wetland W12 is a 1.58± acre scrub-shrub swamp dominated by green ash (*Fraxinus pennsylvanica*), reed canarygrass (*Phalaris arundinacea*) and sensitive fern (*Onoclea sensibilis*). Soils within wetland W12 are mapped as Canandaigua Silt Loam and had a topsoil color of 10YR4/1 with 2% 10YR5/8 mottles and a subsoil color of 10YR5/1 with 15% 10YR5/8 mottles. The texture is silt loam and silty clay loam. This soil fits the NRCS F3 indicator (Depleted Matrix). Hydrology indicators present in Wetland W12 included high water table (A2), saturation (A3) and water-stained leaves (B9). It is EDI's professional opinion that Wetland W12 is Federally jurisdictional due to the apparent off-site connectivity to Buffalo Creek, a traditionally navigable water.

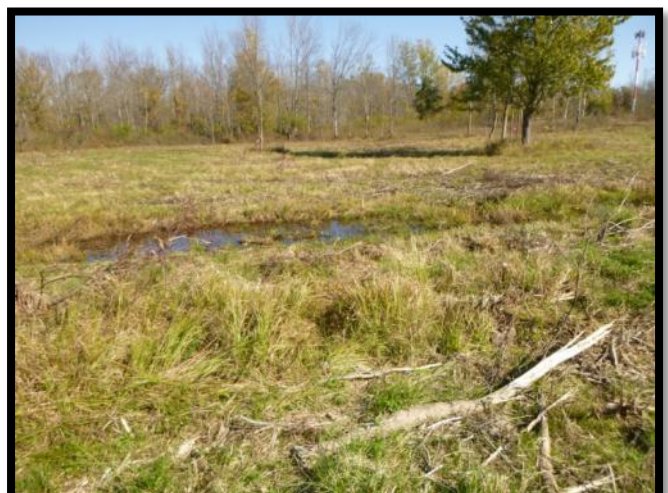
Photo 24: Facing north. Depicts the scrub-shrub swamp community of wetland W13 at data point D22.

Wetland W13 is a 0.75± acre scrub-shrub swamp dominated by gray dogwood (*Cornus racemosa*), glossy buckthorn (*Frangula alnus*), silky dogwood (*Cornus amomum*), devil's beggartick (*Bidens frondosa*) and common rush (*Juncus effusus*). Soils within wetland W13 are mapped as Canandaigua Silt Loam and had a soil color of 10YR3/1 with 4% 10YR5/8 mottles. The texture is silt loam. This soil fits the NRCS F6 indicator (Redox Dark Surface). Hydrology indicators present in Wetland W13 included surface water (A1), saturation (A3) and water-stained leaves (B9). It is EDI's professional opinion that Wetland W13 is Federally jurisdictional due to the apparent off-site connectivity to Buffalo Creek, a traditionally navigable water.

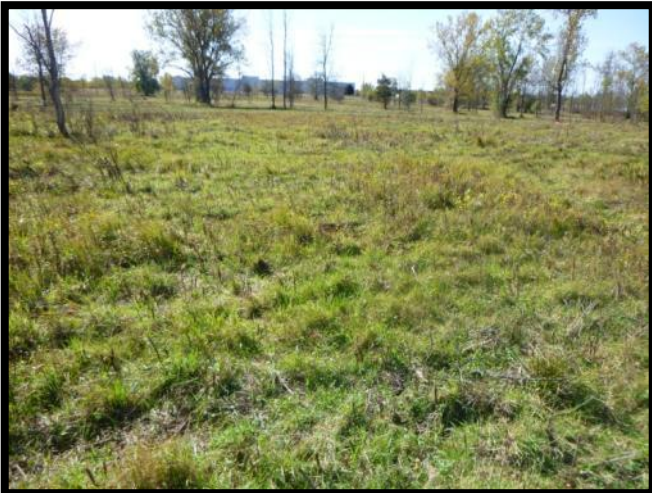
Photo 25: Facing south. Depicts the scrub-shrub swamp community of wetland W14 at data point D23.

Wetland W14 is a 0.27± acre scrub-shrub swamp dominated by green ash (*Fraxinus pennsylvanica*), gray dogwood (*Cornus racemosa*), silky dogwood (*Cornus amomum*), common rush (*Juncus effusus*) and creeping bentgrass (*Agrostis stolonifera*). Soils within wetland W14 are mapped as Candaigua Silt Loam and had a topsoil color of 10YR4/1 with 5% 10YR5/6 mottles and a subsoil color of 10YR5/1 with 30% 10YR5/6 mottles. The texture is silt loam. This soil fits the NRCS F3 indicator (Depleted Matrix). Hydrology indicators present in Wetland W14 included saturation (A3) and water-stained leaves (B9). It is EDI's professional opinion that Wetland W14 is Federally non-jurisdictional due to the lack of connectivity to a traditionally navigable water.

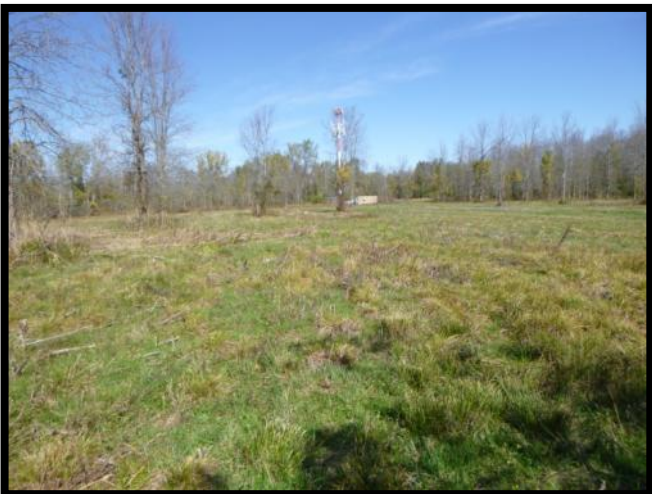
Photo 27: Facing north. Depicts the scrub-shrub swamp community of wetland W15 at data point D25.

Wetland W15 is a 1.40± acre scrub-shrub swamp dominated by gray dogwood (*Cornus racemosa*) and green bulrush (*Scirpus atrovirens*). Soils within wetland W15 are mapped as Niagara Silt Loam and had a topsoil color of 10YR4/1 with 5% 10YR5/8 mottles and a subsoil color of 10YR5/1 with 35% 10YR5/6 mottles. The texture is silt loam and silty clay loam. This soil fits the NRCS F3 indicator (Depleted Matrix). Hydrology indicators present in Wetland W15 included high water table (A2), saturation (A3) and water-stained leaves (B9). It is EDI's professional opinion that Wetland W15 is Federally jurisdictional due to the apparent off-site connectivity to Buffalo Creek, a traditionally navigable water.

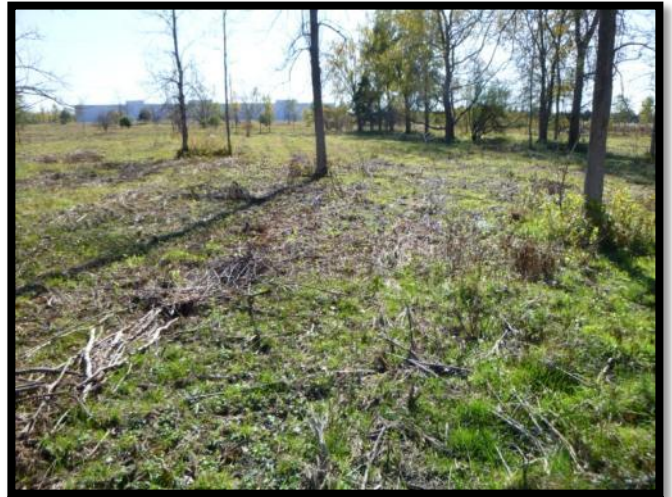
Photo 32: Facing south. Depicts the scrub-shrub swamp community of wetland W16 at data point D29.

Wetland W16 is a 6.01± acre scrub-shrub swamp dominated by green ash (*Fraxinus pennsylvanica*), gray dogwood (*Cornus racemosa*) and broom sedge (*Carex scoparia*). Soils within wetland W16 are mapped as Canandaigua Silt Loam and had a topsoil color of 10YR3/1 with 7% 10YR5/8 mottles and a subsoil color of 10YR5/2 with 20% 10YR5/8 mottles. The texture is silt loam. This soil fits the NRCS F3 indicator (Depleted Matrix). Hydrology indicators present in Wetland W16 included high water table (A2), saturation (A3) and water-stained leaves (B9). It is EDI's professional opinion that Wetland W16 is Federally jurisdictional due to the apparent off-site connectivity to Buffalo Creek, a traditionally navigable water.
