FLOOD PLAIN INFORMATION

BUFFALO CREEK N. Y.

IN THE TOWNS OF ELMA AND WEST SENECA

MAIN REPORT AND TECHNICAL APPENDIX

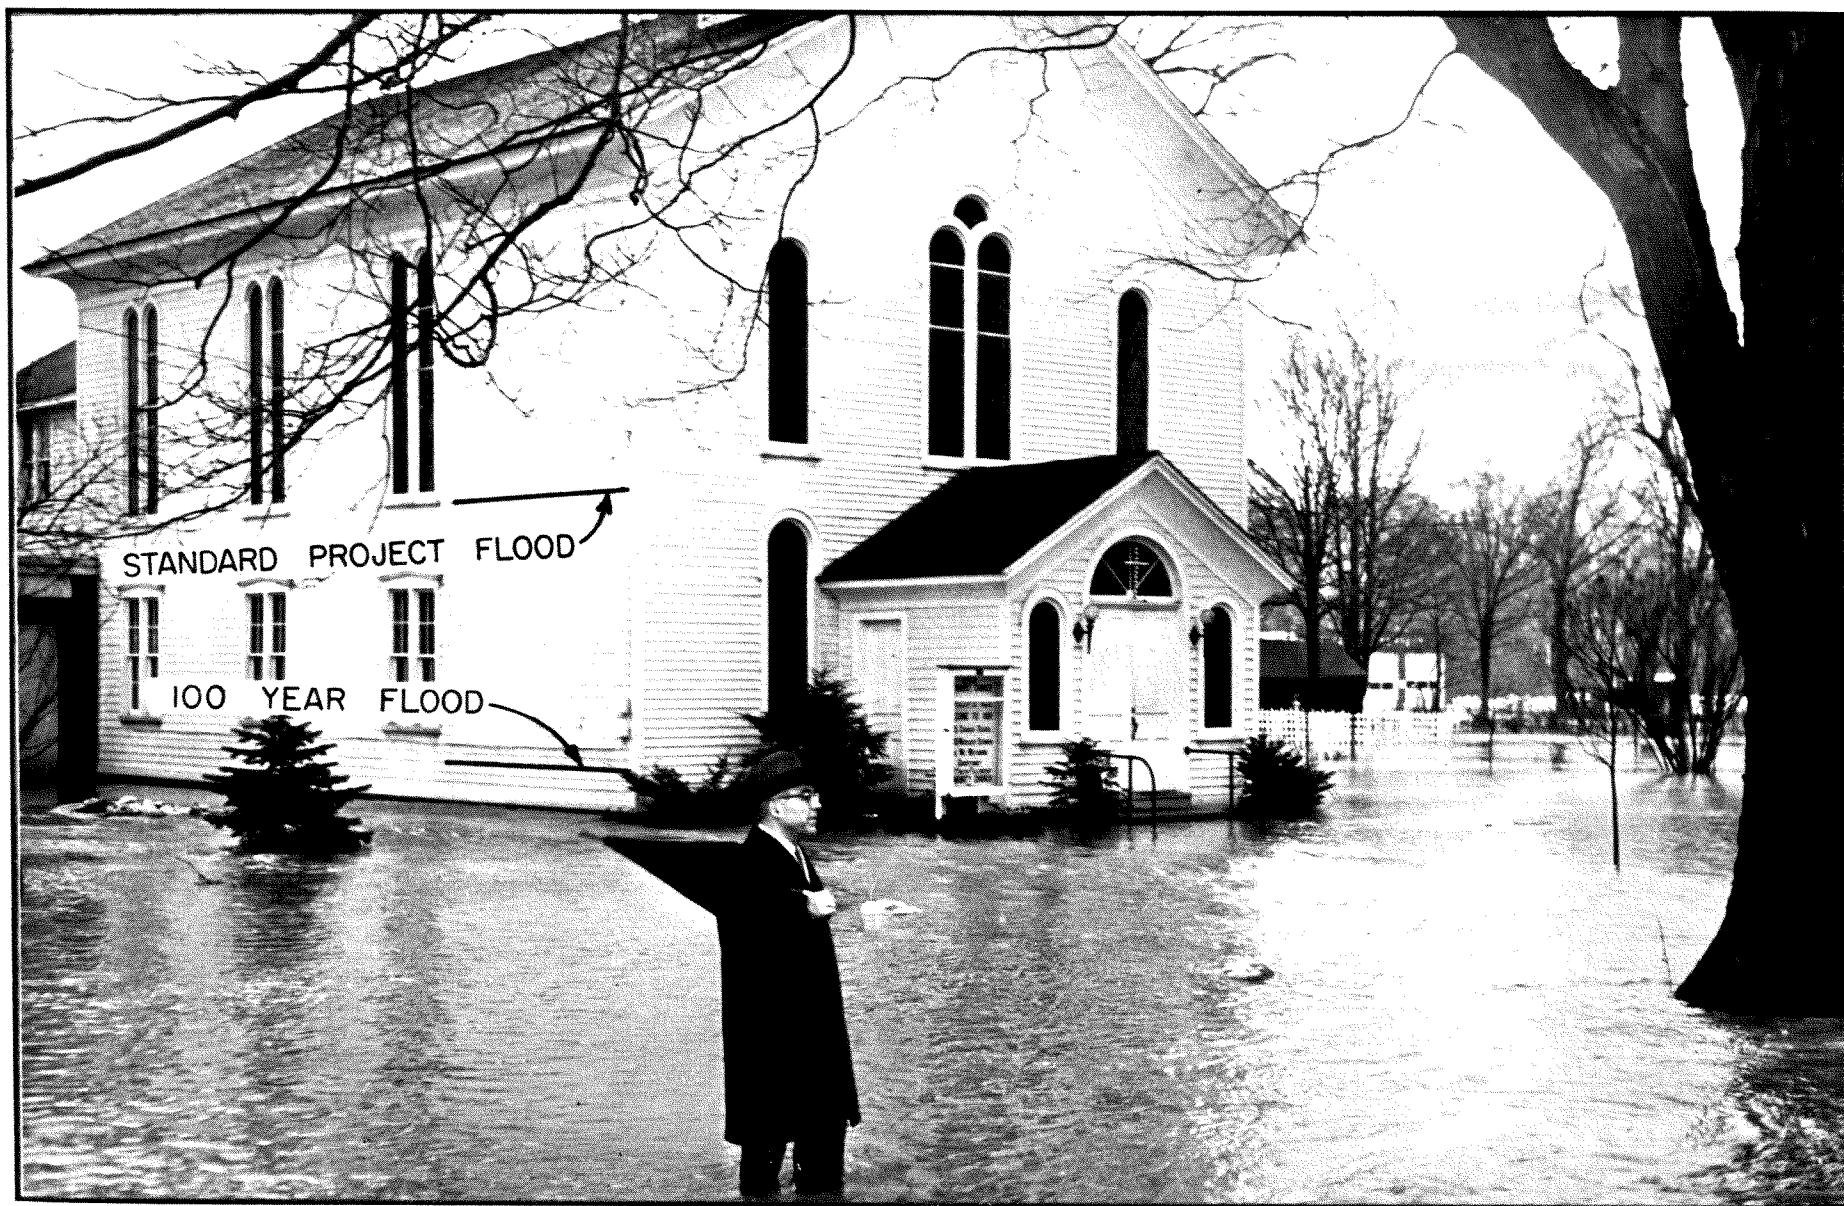
FRONTISPIECE

Elma Methodist Church during March 1962 flood.

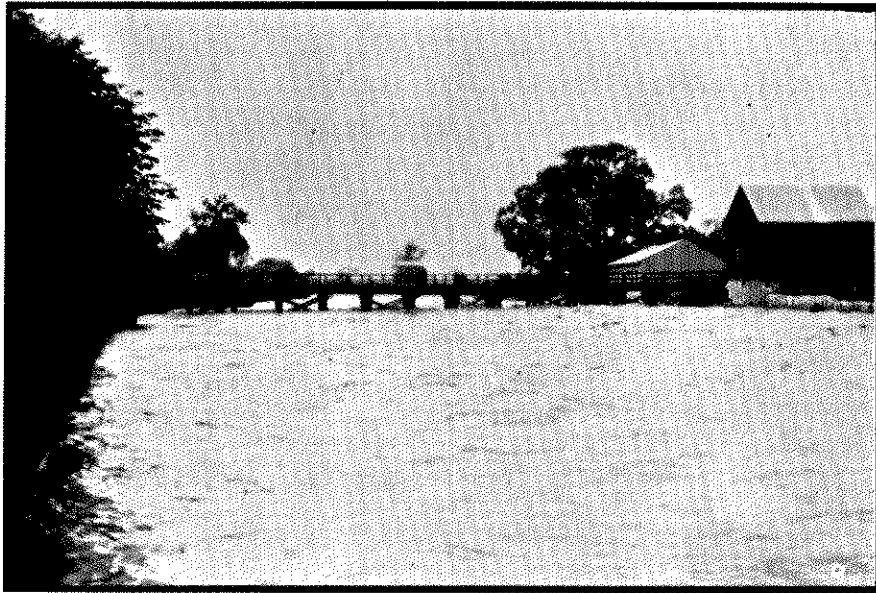
Photo No. 1. Looking downstream at temporary bridge used during construction of Union Road bridge during the flood of the summer of 1928.

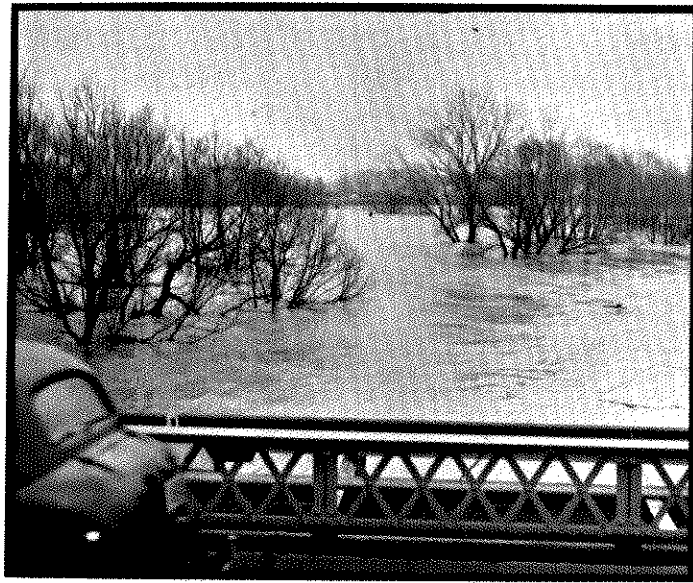
Photo No. 5. Looking upstream from Harlem Road Bridge at the flooded flats at the confluence of Buffalo and Cayuga Creeks during the March 1955 flood. Clinton Street is in the left background.

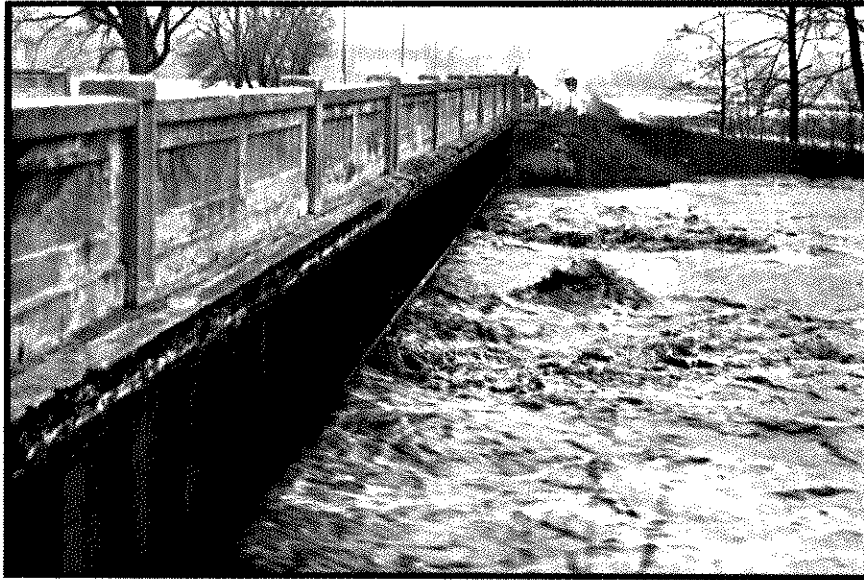
Photo No. 7. Looking south from the north abutment at the downstream side of the Transit Road bridge during the March 1955 flood.

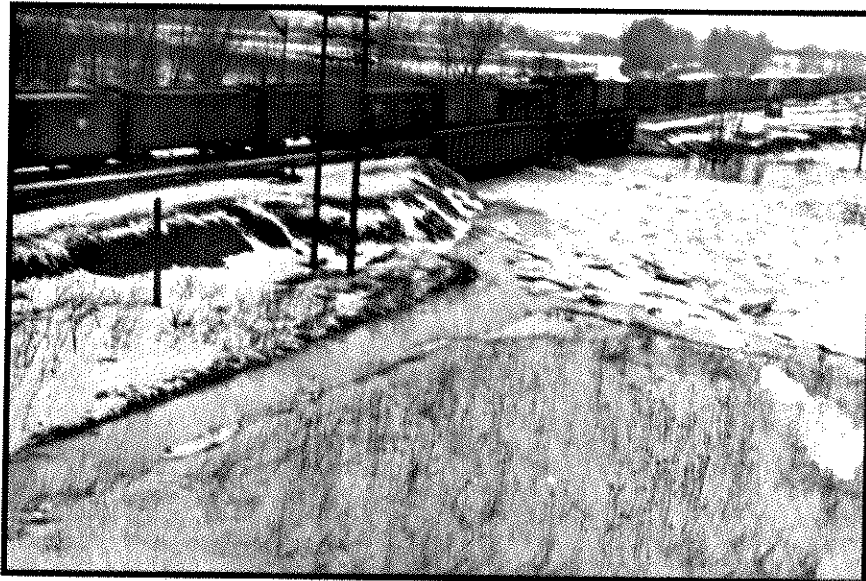
Photo No. 8. Looking at upstream side of the N.Y.C. R.R. bridge from Indian Church Road. This flood took place during the 1950's.

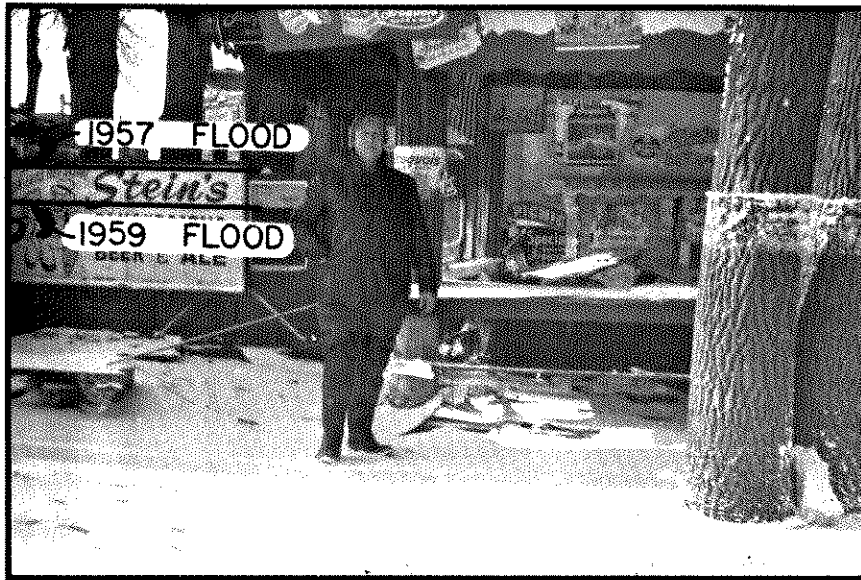
Photo No. 9. Ice lines indicate January 1959 flood elevation at Huppertz Grove, Collins Avenue. Near mile 0.15.

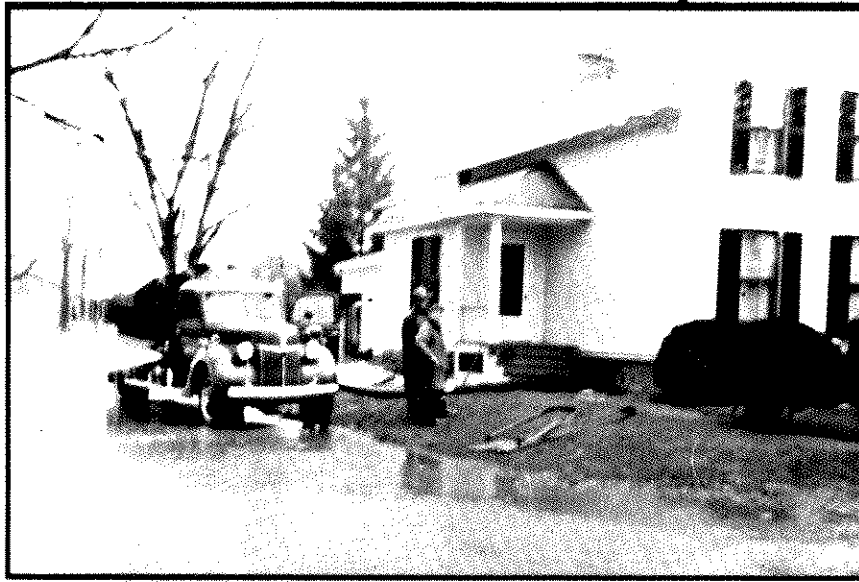
Photo No. 11. Firemen shown pumping overland flood water out of basement at residence on Borden Road after water receded, during the March 1962 flood.

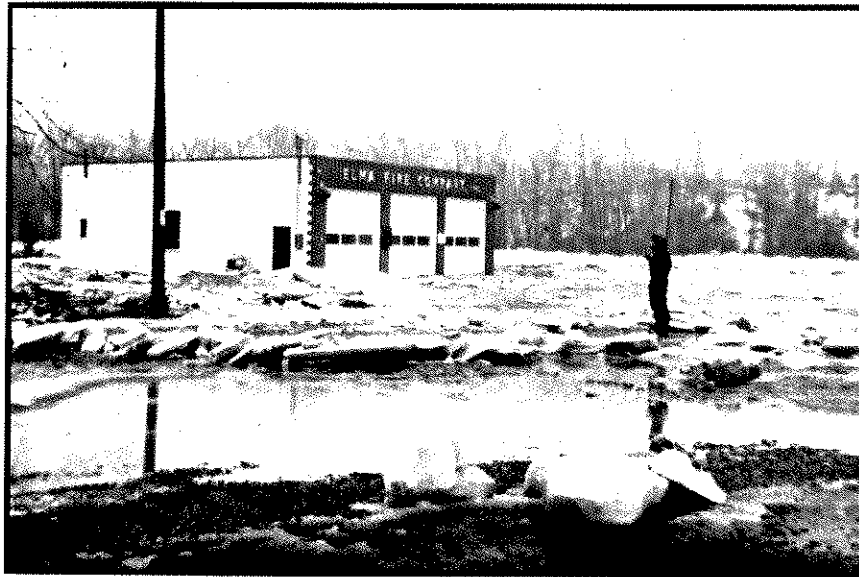
Photo No. 12. The new Elma Fire Hall during the March 1962 flood. The floor was covered by 8 inches of water.

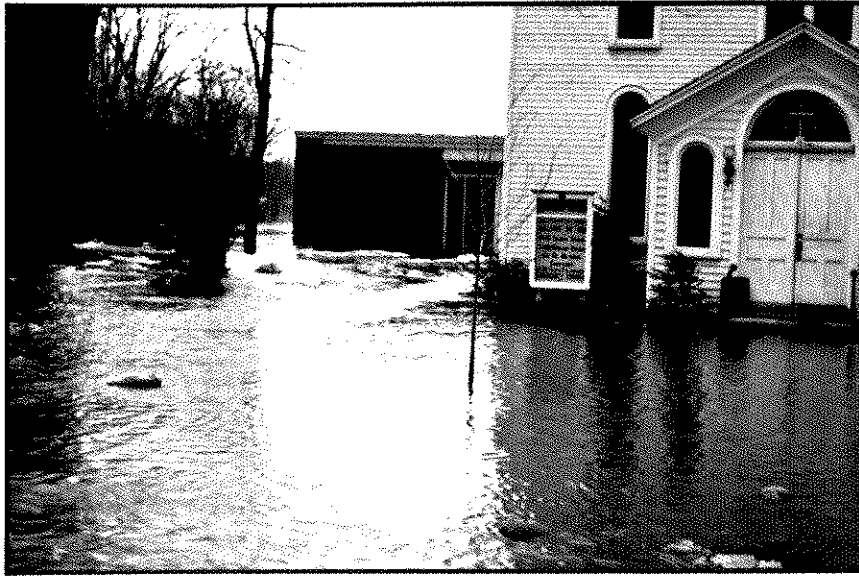
Photo No. 13. Elma Methodist Church and Sunday School addition on Bowen Road, during the March 1962 flood.

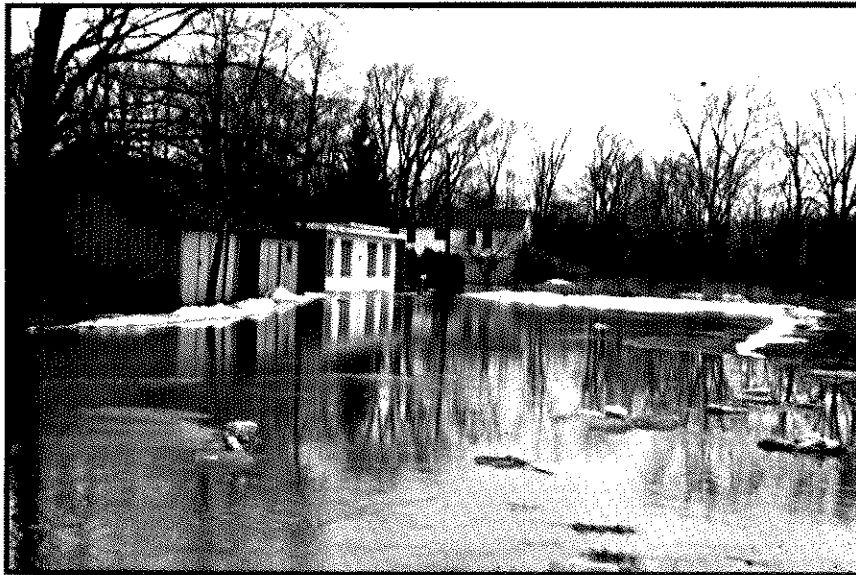
Photo No. 14. Rear of Sunday School addition during the March 1962 flood. Addition now being used for regular school classes. The addition had 4 inches of water on the first floor.

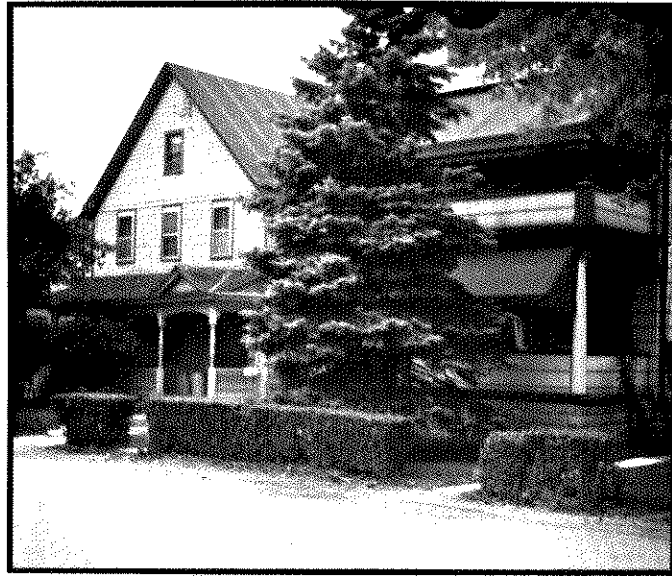
Photo No. 15. Homes on School Street near mile 2.25 which are affected by sewer backup when sanitary sewer manholes are covered.

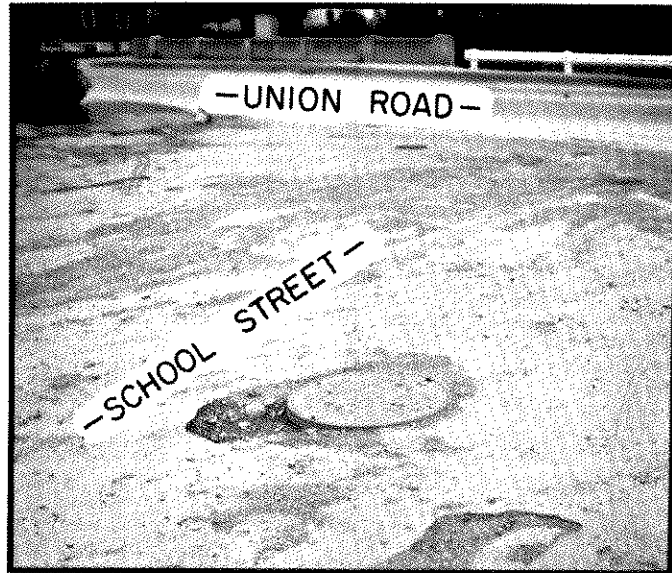
Photo No. 16. Manhole subject to surface flooding, about once in 5 years and causes basement flooding in the homes shown in photo no. 15. The homes would be subject to direct flooding about once in 20 years.

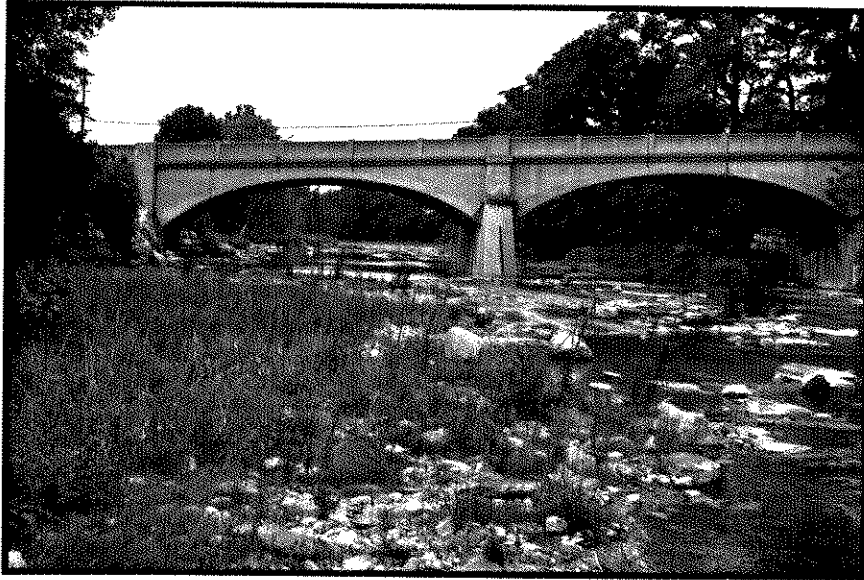
Photo No. 19. Looking downstream at Borden Road bridge showing rock channel bottom and shoals.

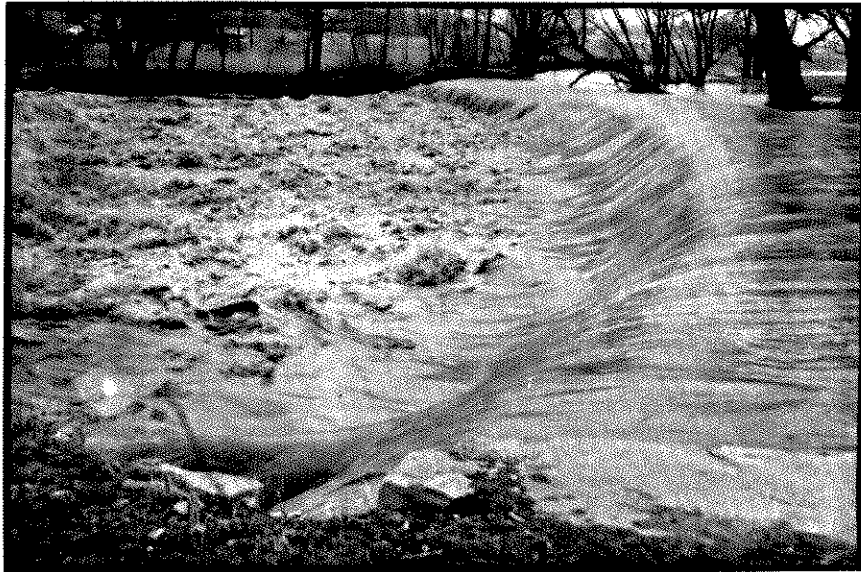
Photo No. 21. Blossom Dam near mile 5.95. Photo shows increase in water surface at the dam during the moderate runoff of April 1959.

44. At the present time there are dams at Blossom and Elma which are no longer in use and which project 3 to 4 feet above the natural creek bottom. Shoal areas have formed at the upstream end of the pools and ice floes and debris are easily grounded. If these dams are not serving any useful purpose removing them would reduce high water elevations in the immediate area. Pictures of the Blossom and Elma dams are shown on exhibits 11 and 12. Picture 21 shows the increase in water surface at the Blossom dam during a moderate runoff. Picture 22 shows that equipment has been engaged in removing shoal material from upstream of the Blossom dam.

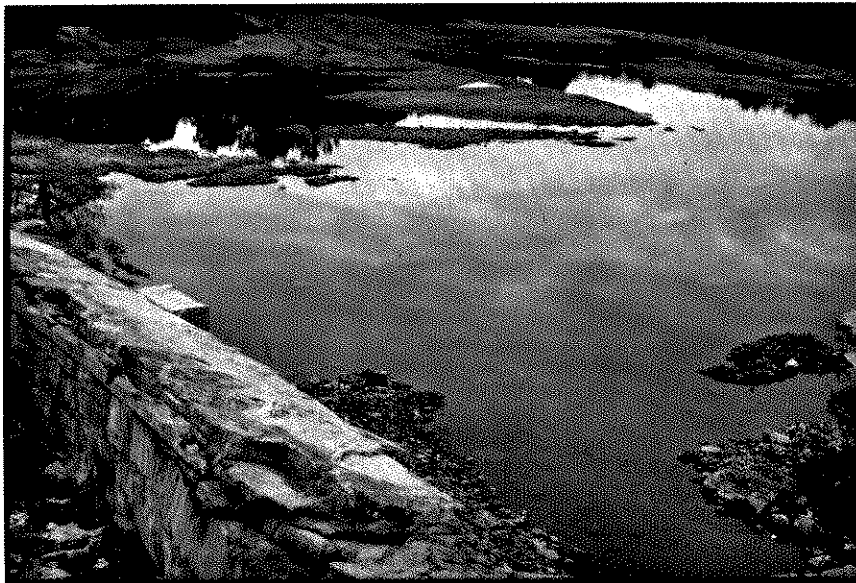
Photo No. 22. Looking upstream from Blossom Dam. Photo shows removal of gravel bar at upper left and shows riprap on bank at upper right which was placed by the Soil Conservation Service.

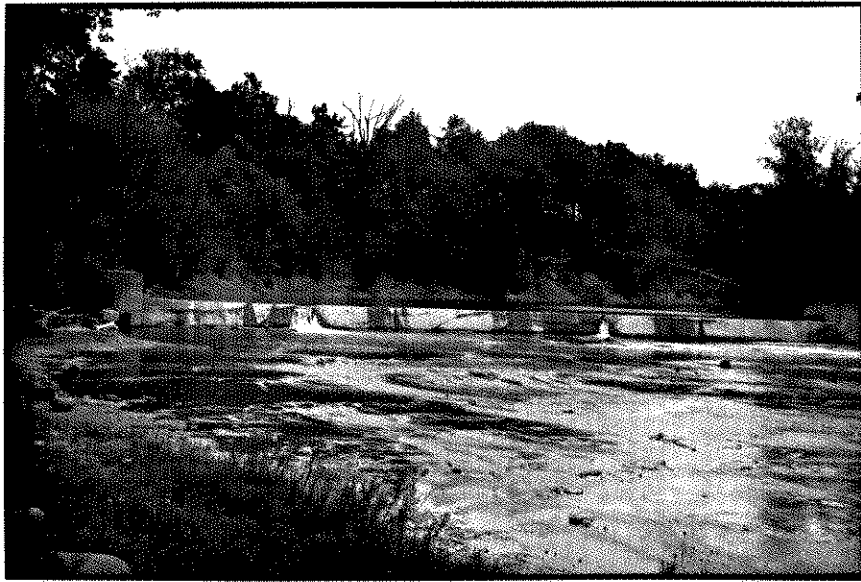
Photo No. 23. Elma Dam upstream of Bowen Road near mile 10.2. Note shale on right bank upstream of the dam.

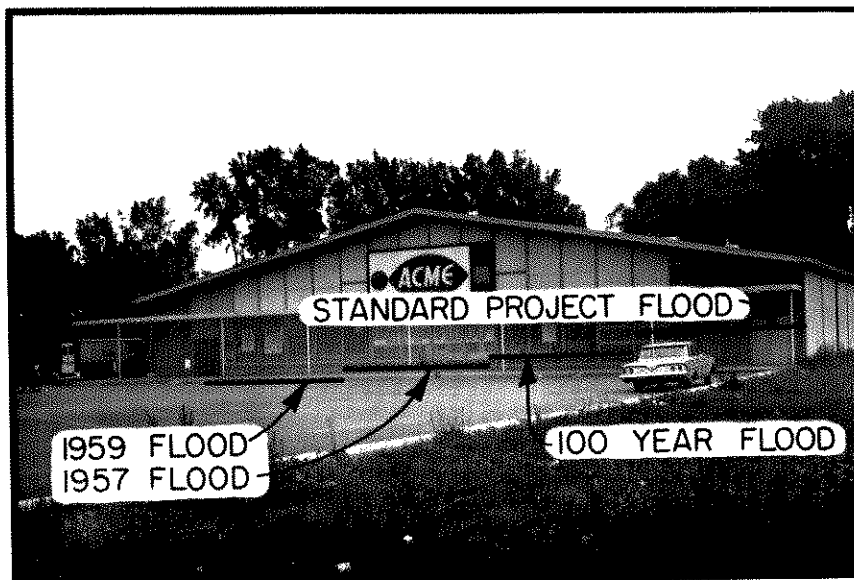
Photo No. 28. Supermarket on Harlem Road in the flood plain. The horizontal lines indicate the comparative levels of several floods.

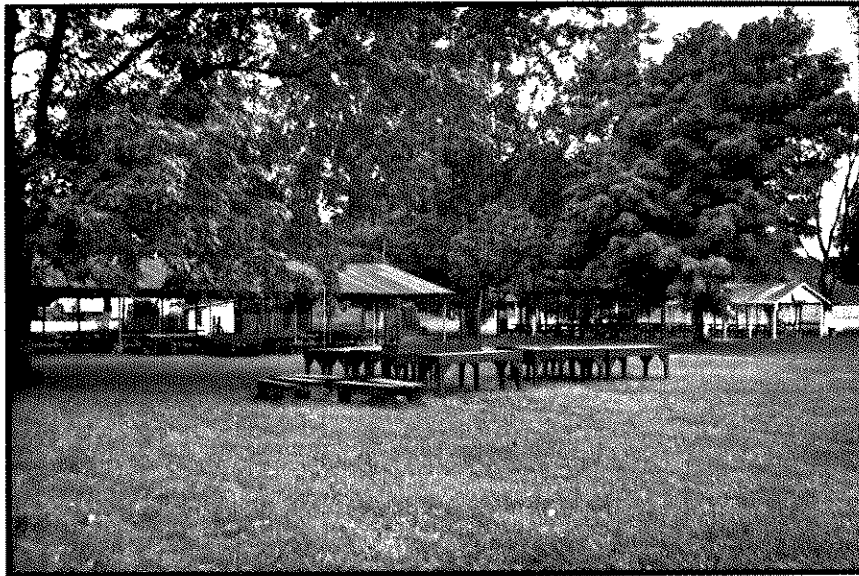
Photo No. 31. Island Park at Gardenville near mile 2.3. This area was flooded by about 2 feet of water in the 1955 and 1956 floods.
